EXISTING CONDITIONS ASSESSMENT

EXISTING SITE & BUILDING DATA

This Regulatory Assessment will seek to convey to what degree the **Broadmeadow Elementary School**, in its current condition, complies with current building codes and regulations. The Assessment does not attempt to define a scope of work, but rather highlight specific non-complying conditions and identify which conditions would require correction if a repair, alteration, addition, or change of use were to be proposed for the facility.

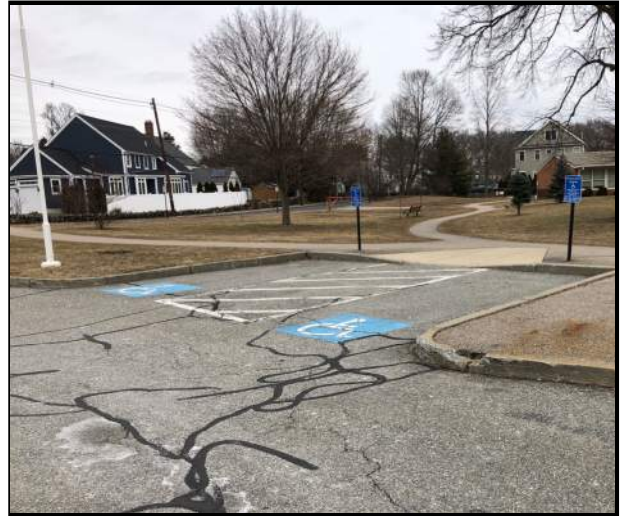
The pavement in the parking area and entrance loop is in fair condition (image 1, 2 & 3). The sidewalk and curb are in good to fair condition with some cracking and disrepair of the sidewalk and damage to curbing (Image 8).

Image 8: Accessible parking near front entrance

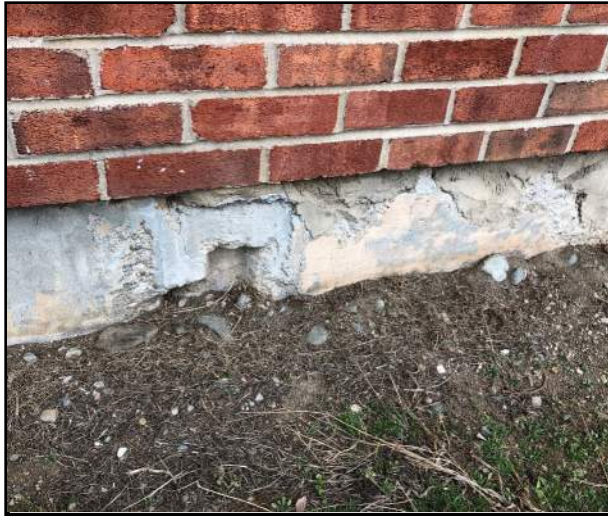
<i>Specific Issues</i>	<i>Recommendations</i>
Cracking and spalling of concrete foundation wall will increase with freeze / thaw cycles (Image 1, 2 & 3)	Remove loose materials, prep substrate for patching, apply appropriate patching materials and parge as necessary
Wet areas near foundation walls due to flat or negative sloped grades	Review grading and drainage to create positive drainage away from building

Image 1: Previously patched foundation area

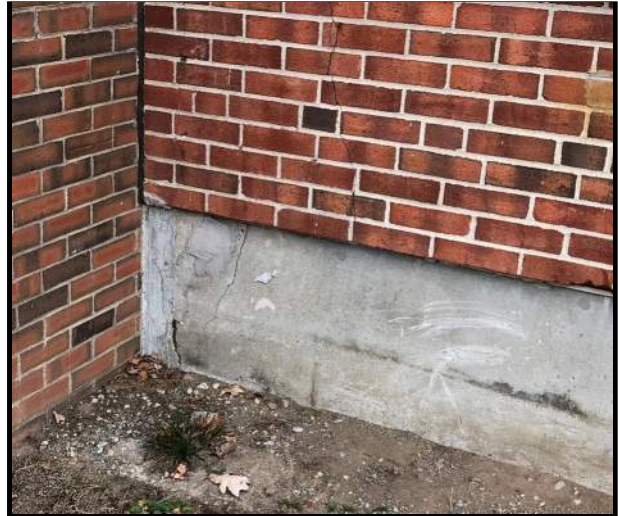
Image 2: Some foundation cracking in corner

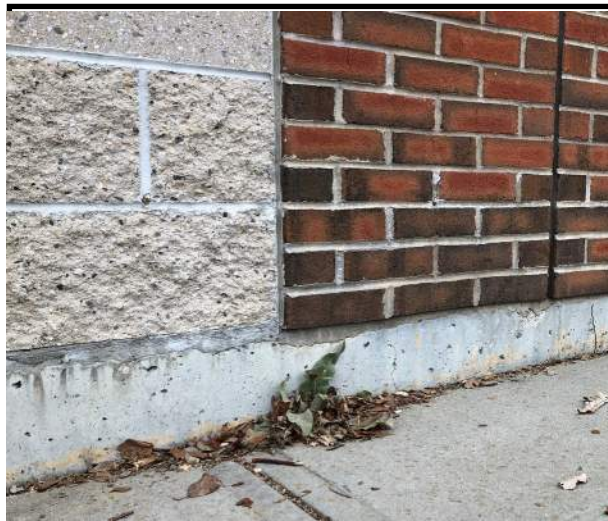
Image 3: Spalling concrete at joint

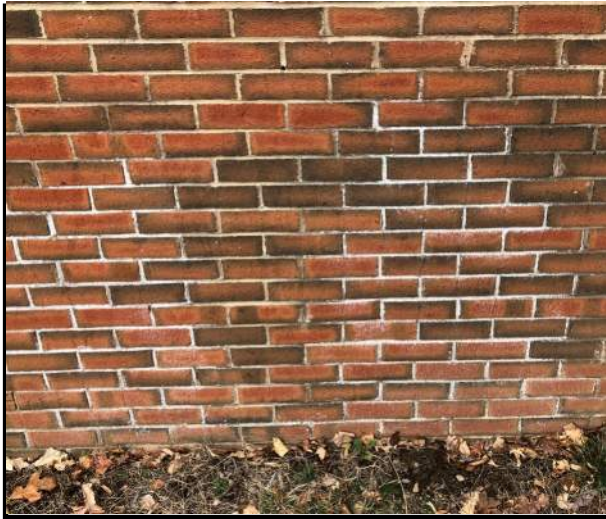
<i>Specific Issues</i>	<i>Recommendations</i>
Areas of growth on masonry surfaces (Image 7)	Clean areas with appropriate surface wash
Small areas of rust / dark discoloration on the grey ground face CMU (Image 8)	Appear to be inherent with the unit masonry product used for the project—no action required.
Minor areas of damaged brick and cracking (Image 9 & 10)	Remove loose, cracked or damaged bricks and replace with new.
Additional areas of brick and exterior wall that need to be cleaned (Image 11)	Clean and scrape areas with appropriate surface wash

Image 7: Staining and mildew on brick

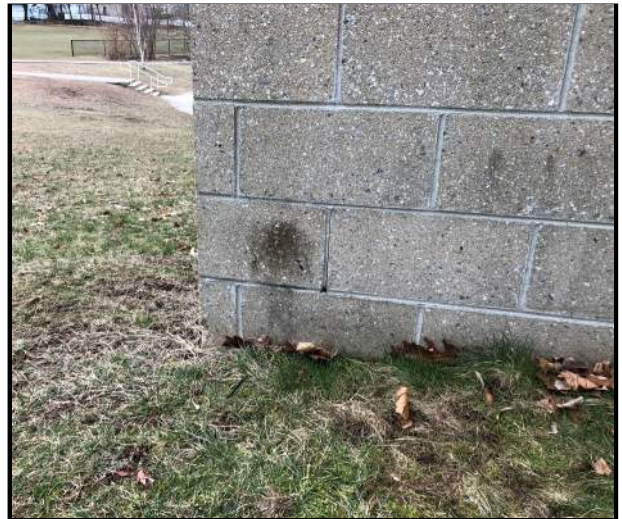
Image 8: Staining on CMU walls

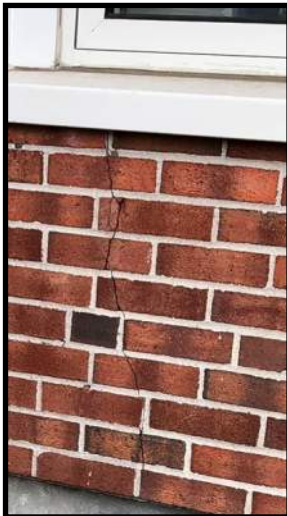
Image 9: Cracked Bricks

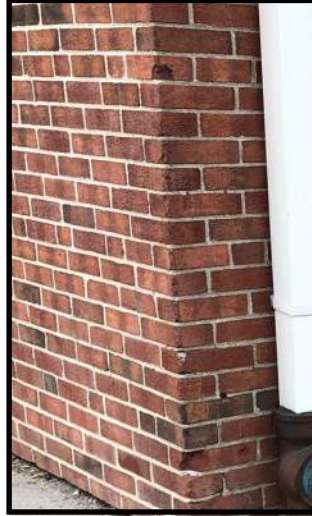
Image 10a: Damaged Bricks

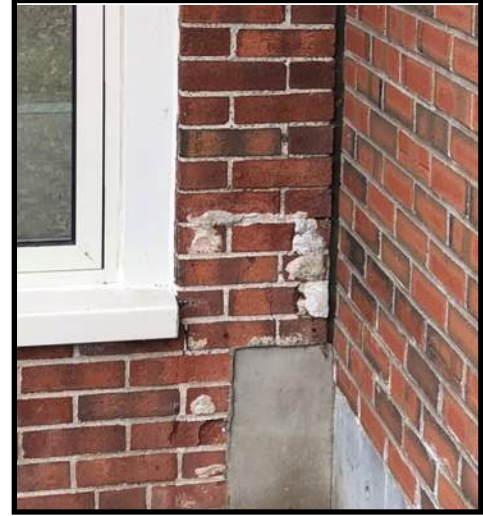
Image 10b: Excess grout on walls

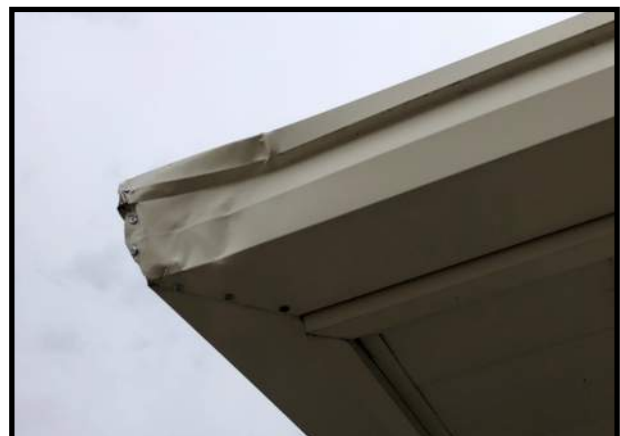
<i>Specific Issues</i>	<i>Recommendations</i>
Impact damage has occurred to the gutter at the soffit	Remove and replace gutter system in area of damage

Image 18: Damage to gutter system at soffit

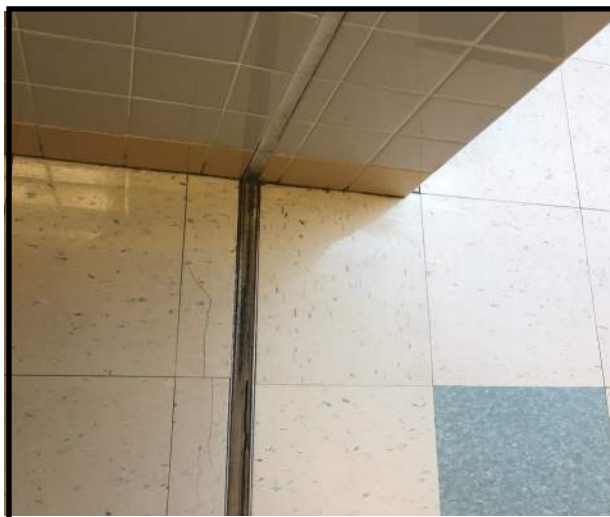
The flooring throughout the facility is a mix of durable, institutional grade materials. The main entrance area (Image 1) and most of the hallways, classrooms, and cafeteria is Vinyl Composition Tile (VCT) with rubber or tile base (Image 2&3). The VCT is in good condition with some signs of age (Image 4) and cracking at transition joints (Image 5).

Image 5: Damaged flooring at transition

<i>Specific Issues</i>	<i>Recommendations</i>
Aged VCT	Replace VCT in areas where it appears aged and worn
VCT cracking at transition joints	Replace cracked VCT tiles
Quarry tile and grout is stained	Clean quarry tile and grout—replace any tiles that are cracked and damaged
Painted stair nosing is worn	Repaint nosing or replace treads with integrated color strip

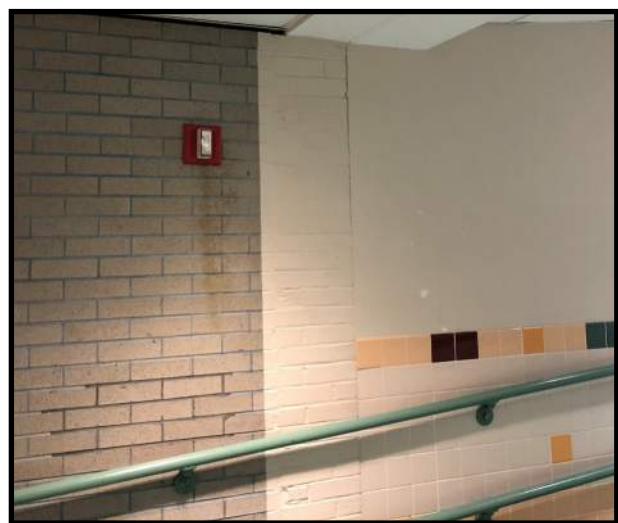
Several corridors have exposed brick walls (Image 13). Most of the brick is in good condition with some locations of staining (Image 14).

Image 14: Staining on brick walls

<i>Specific Issues</i>	<i>Recommendations</i>
Stained tile and grout	Tile base in the corridors and tile walls in the restrooms require cleaning with a tile and grout cleaner. Consider replacing the lowest two rows of tile in the corridor with a darker tile and grout to reduce the appearance of dirt and staining
Base of wood work is stained	Clean woodwork with wood cleaner. Assess floor cleaning methods to avoid continued staining of wood and tile base
Damage to GWB walls	Repaint areas that have had damage due to the hanging of posters. Where walls are damaged from impact patch and repair walls. Consider use of plastic laminate wall covering in restrooms and other means of attaching notifications on painted corridor walls
Staining on brick walls	Review source of staining. Use brick and grout cleaner to remove staining

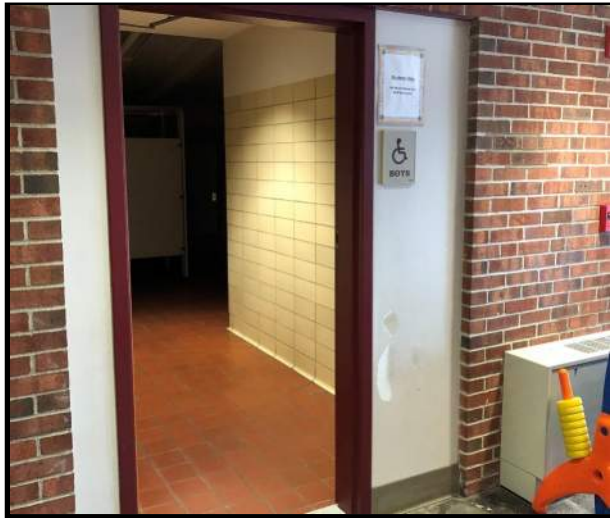
The kitchen and servery, janitor closets and restrooms in the older section of the school have quarry tile floors in good to fair condition (Image 7). The tiles themselves are in good condition however the tile and grout appear to be dirty and aged. Multi-student use restrooms in the renovated portion of the building have tile flooring in good condition (Image 8).

Image 7: Quarry tile in restroom

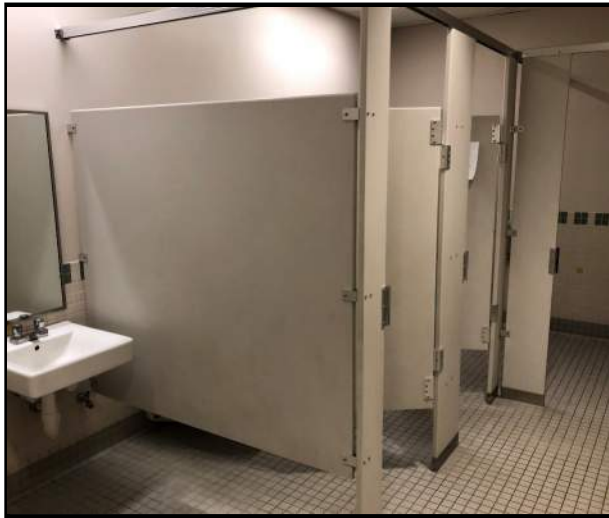
Most multi-user restrooms have partitions that are in fair condition (Image 29) .

Image 29: Restroom partitions
