## EXISTING CONDITIONS ASSESSMENT

## EXISTING SITE & BUILDING DATA

Nitsch Engineering has performed research of the existing site conditions for the Mitchell School at 187 Brookline Street in Needham, Massachusetts. Nitsch Engineering also conducted a site visit on December 13, 2019 to observe the overall site, take pictures and provide a preliminary outline of short and long term needs for the school. Nitsch Engineering included anticipated site permitting requirements for the Mitchell School for any proposed site work.

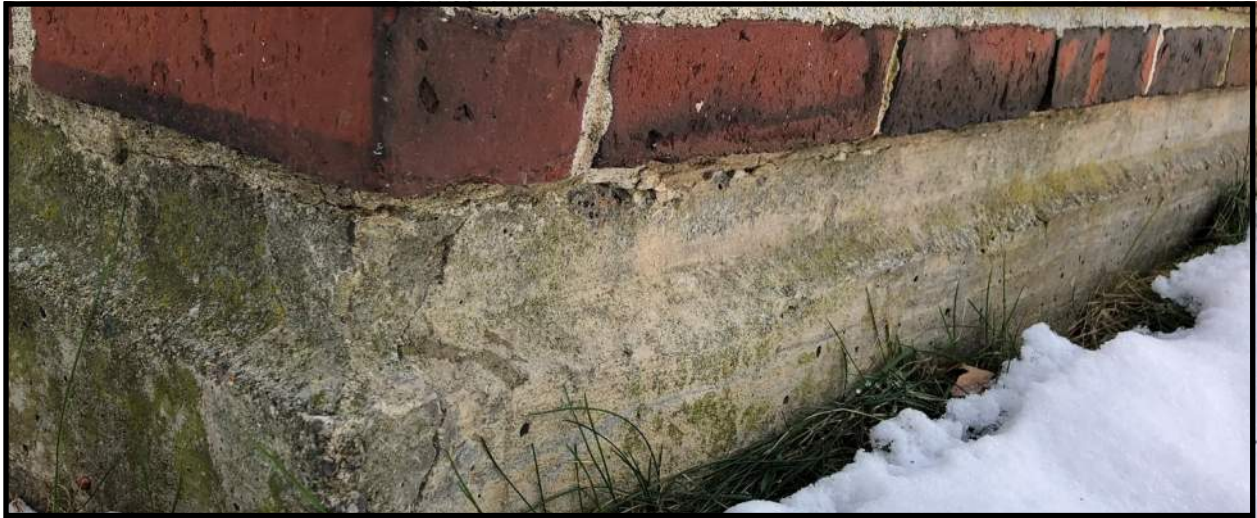
<i>Specific Issues</i>	<i>Recommendations</i>
The entire foundation system is uninsulated and appears to not be dampproofed / waterproofed (Image 1).	Install of minimum R-10 rigid insulation with above grade insulation protection, and appropriate flashing / trim components over a complete waterproofing system as part of a significant facility envelope upgrade / renovation project.
Foundation window or vent that was filled in with plywood and has asphalt poured up to face of building (Image 2) creating space for water infiltration.	Remove asphalt in this area. Remove plywood panels. Fill openings with masonry. Patch and repair asphalt.
Spalling concrete foundation wall (Images 3).	Remove loose / damaged materials, prep for patching, and install mortar pointing, masonry materials, grout, etc... as required for associated repairs.
The asphalt does not appear to be sloped for drainage. Water and debris enters the space between the foundation and the asphalt (Image 4). The freeze / thaw cycle can cause damage that goes undetected.	Remove asphalt that is placed against building foundation. Install drainage system or landscaping.

Image 1: Exposed foundation wall (original –1948—portion of the building)

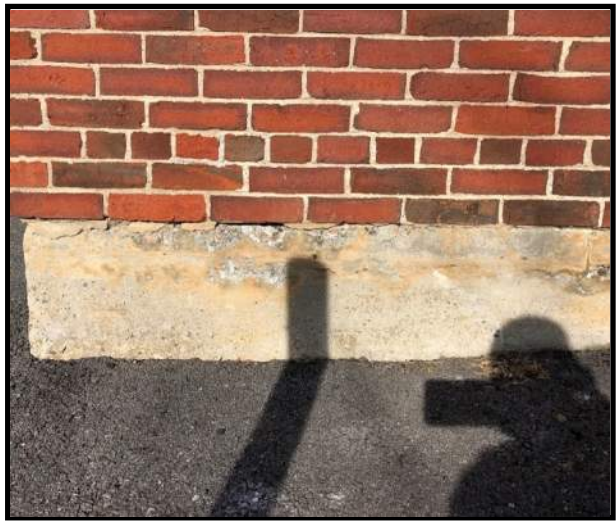
The original cast in place concrete foundation is in fair condition. Interior access to the foundation area is limited as the wall varies in height and accessibility from the basement storage area, crawl space, and mechanical room. Some spalling of the concrete has occurred on the west side of the building where asphalt pavement has been poured up to the concrete wall and aggregate is visible along much of the foundation wall. More significantly the entire assembly is uninsulated. In many areas the wall remains damp due to poor drainage. In some areas there is moss growing on the foundation wall.

Image 3: Spalling of foundation wall

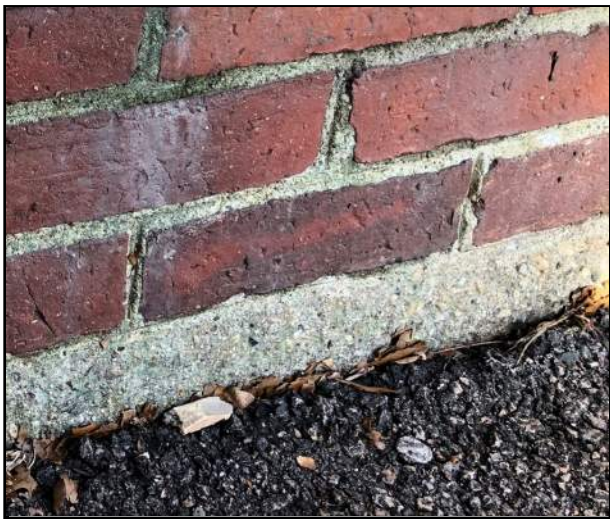
Image 4: Debris & water collects at edge of asphalt

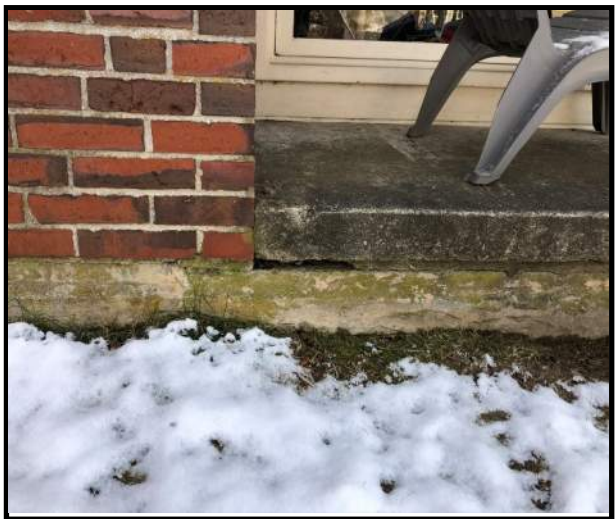
Missing grout at window and door sills in 1968 addition (Image 5).	Review sills for missing grout and damage due to freeze / thaw cycles. Repair grout and / or replace damaged sills.

Image 5: Missing grout at door sills

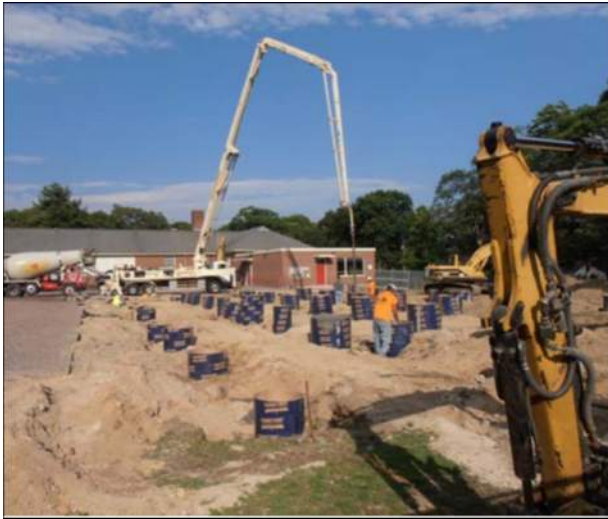
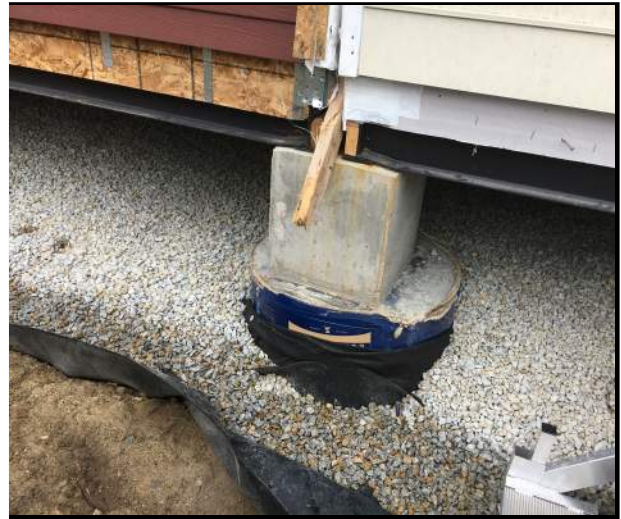
The modular classrooms are set on poured in place concrete piers. Foundations are in very good condition (images 6 & 7)

Image 6: Foundation piers for 2015 modular building

Image 7: Foundation pier of 2019 modular building

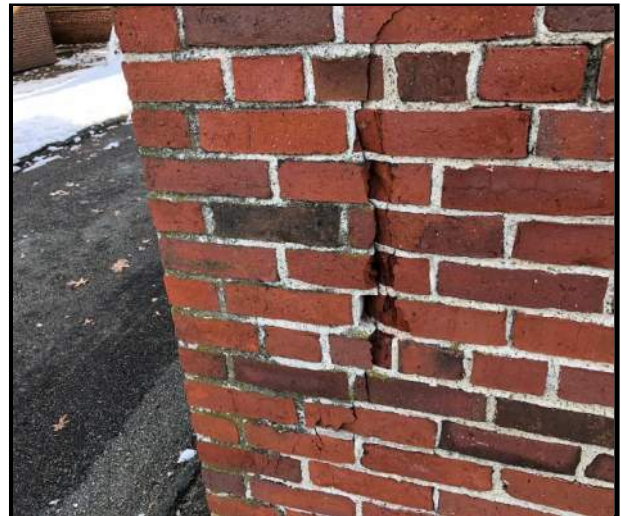
Image 9: Damaged bricks

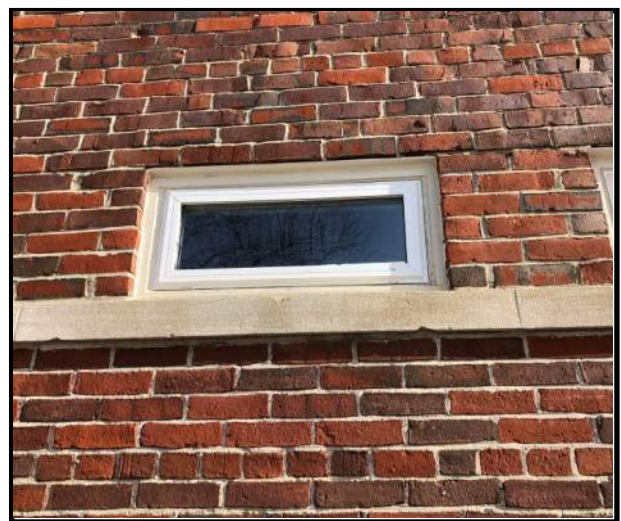
Image 11: Brick wall in poor condition

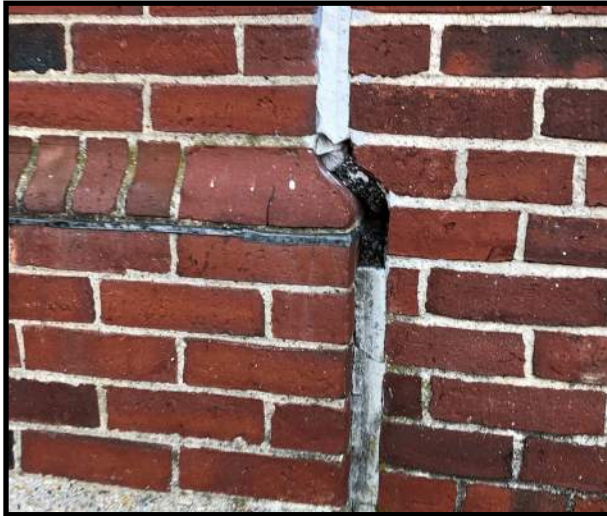
Re-grouting and repointing is needed throughout the building exterior. The expansion joint between the 1958 kindergarten addition and the original building is in need of repair with the appropriate expansion joint materials (Image 12).

Image 12: Building expansion joint

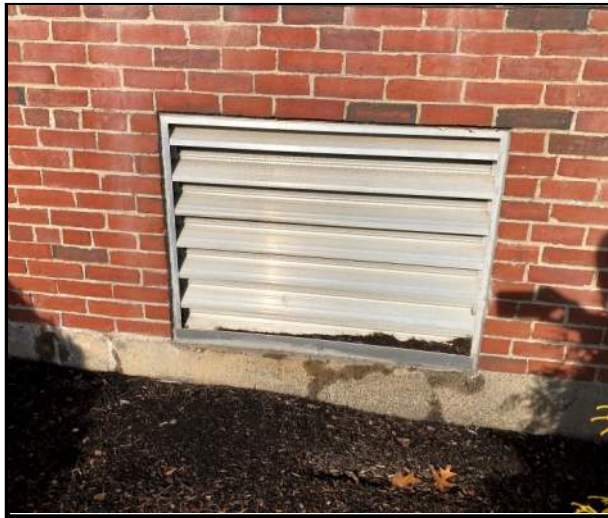
Image 24: Vent with debris

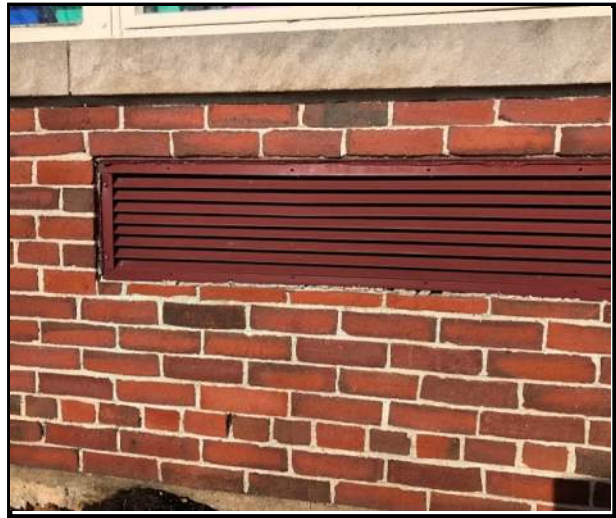
Image 25: Damaged and missing caulk and sealant

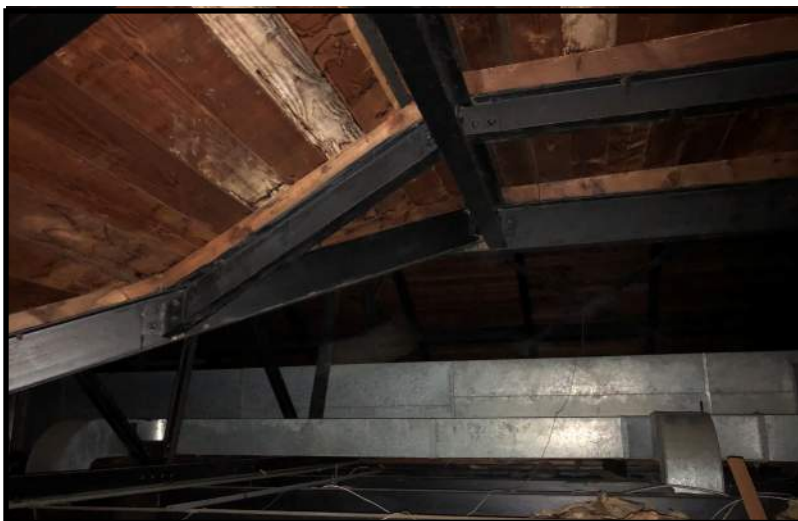
One of the more significant issues at the Mitchell School is the lack of insulation in the attic space of the 1949 building (Image 27). There was approximately 2" to 3" of fiberglass batt insulation observed directly on top of the plaster ceiling. This insulation was inconsistent in many areas due to ductwork, piping and electrical conduit penetrating through the ceiling. It was evident that some of the insulation had been moved, most likely by various workers over the years accessing the space to maintain, repair and upgrade the building systems. The insulation system was inadequate as originally installed and is a difficult system to maintain continuity. Modular classroom building roofs are in very good condition.

Image 27: 1948 roof structure

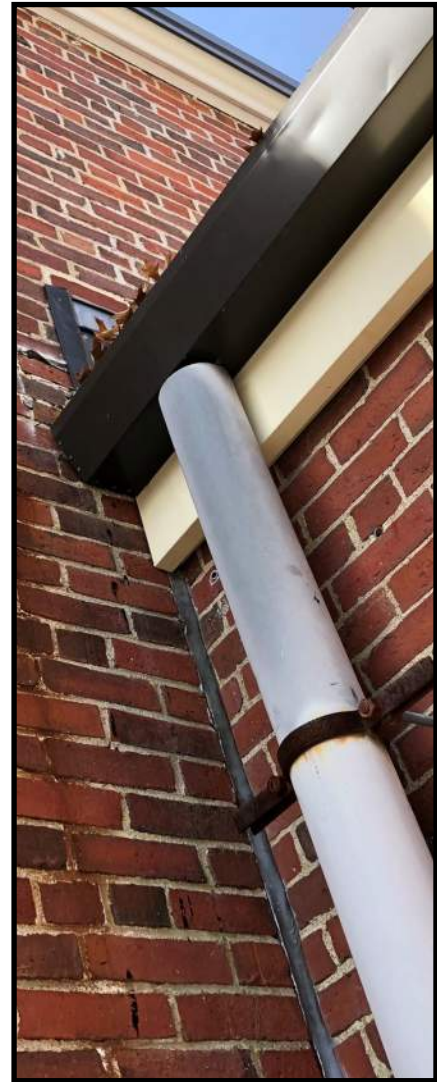
Image 28: Gutter with debris

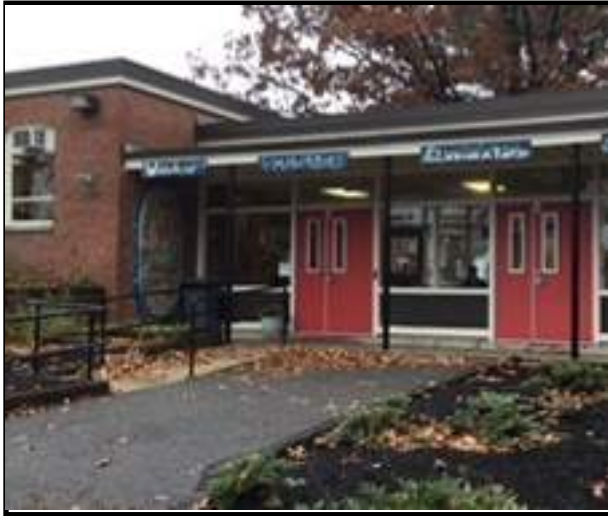
Image 37: Main entrance ramp

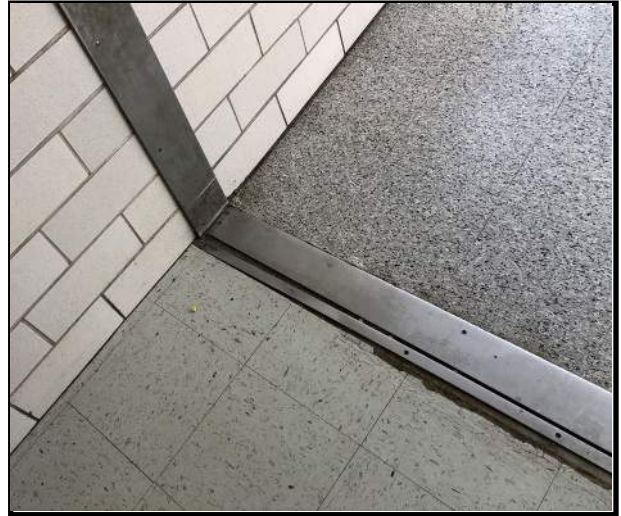
Image 8: Cracking of tiles at transition points

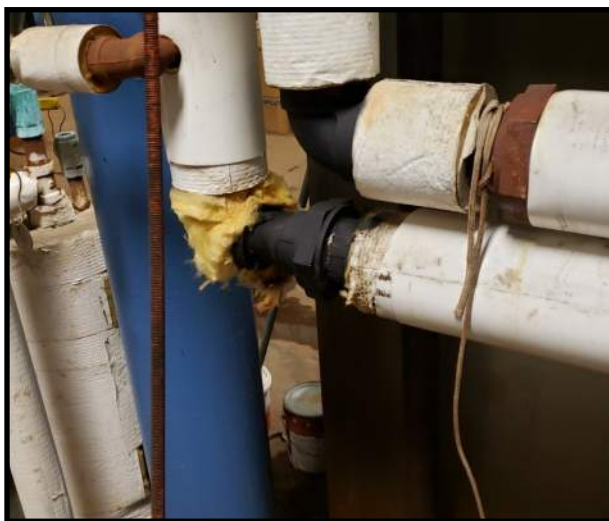
Image 11: Missing insulation

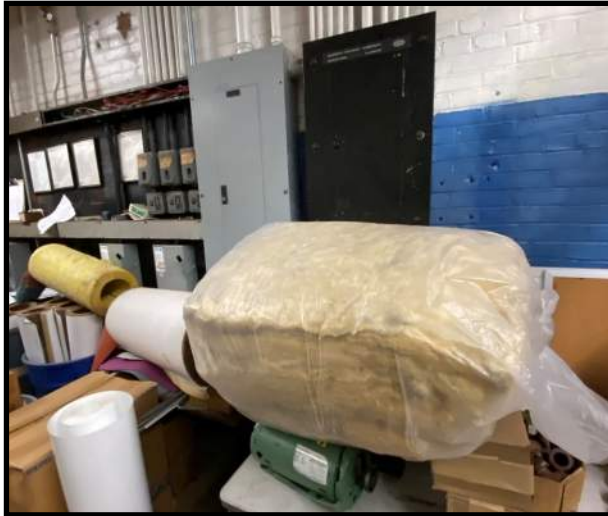
Image 1: Panel board with storage placed in front

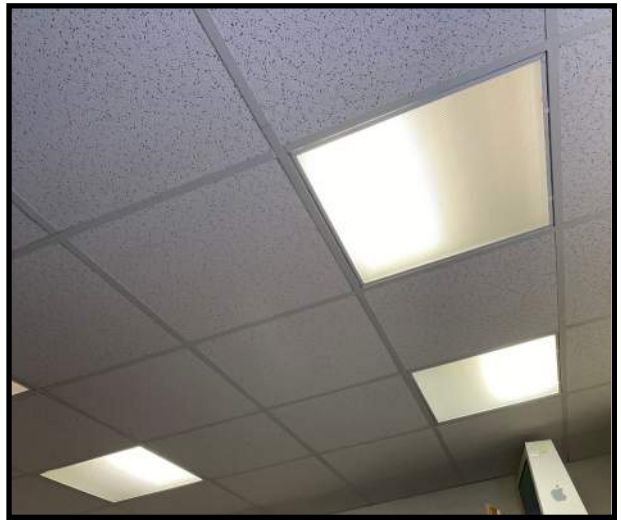
Image 21: Lighting with missing lamps
