EXISTING CONDITIONS ASSESSMENT

EXISTING SITE & BUILDING DATA

This Regulatory Assessment will seek to convey to what degree the **Broadmeadow Elementary School**, in its current condition, complies with current building codes and regulations. The Assessment does not attempt to define a scope of work, but rather highlight specific non-complying conditions and identify which conditions would require correction if a repair, alteration, addition, or change of use were to be proposed for the facility.

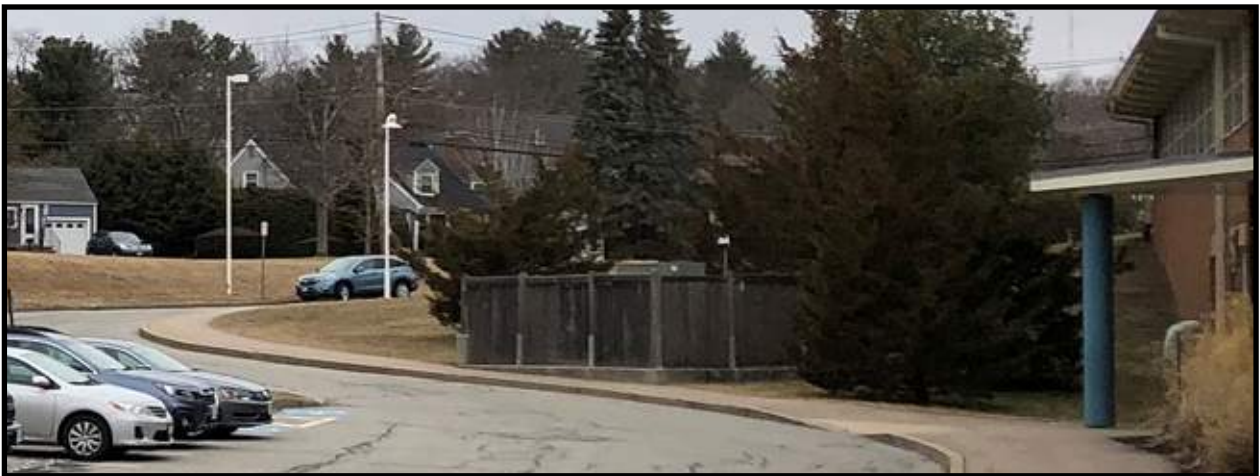
Image 3—Drop in grade from entrance loop to parking area (looking north)

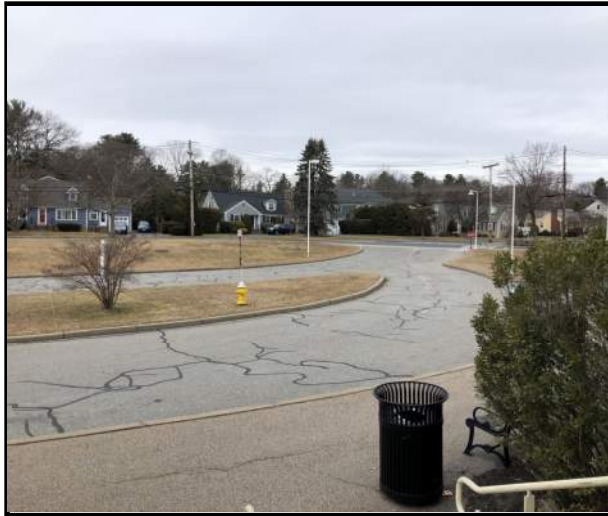
Image 1: Access drive from Broad Meadow Road

The pavement in the parking area and entrance loop is in fair condition (image 1, 2 & 3). The sidewalk and curb are in good to fair condition with some cracking and disrepair of the sidewalk and damage to curbing (Image 8).

<i>Specific Issues</i>	<i>Recommendations</i>
Walkways around the building are too narrow to allow emergency vehicle access	Consider making the sidewalks wider and structurally capable of supporting emergency vehicles
Paving area is in fair to poor condition	Mill and overlay pavement where cracking has occurred

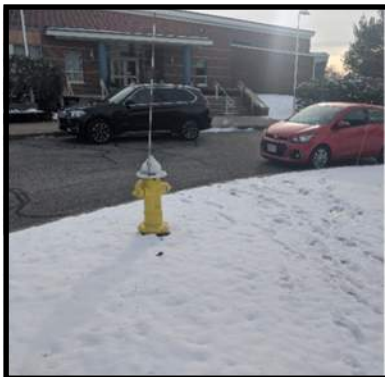
There are three fire hydrants on the property: one hydrant is located on the island of the front drop off loop (Image 13), one is located at the south end of the parking lot, and one is located along the rear drop-off loop.

Image 13: Hydrant at front loop

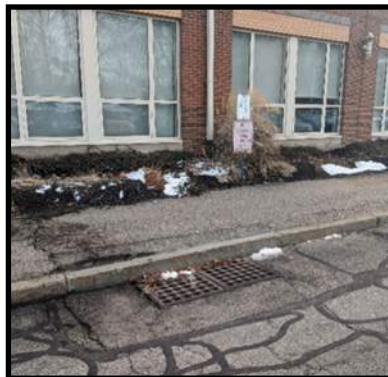
Drainage for Broadmeadow Elementary School consists of a series of catch basins and an area drain (Image 14). There are two catch basins in the front loop. There is a single catch basin at a low point in the landscaped area to the west of the building. The rest of the western side of the building sheet flows to the parking lot which has 4 catch basins. Stormwater not captured by the catch basins sheet flows to the baseball field at the south end of the site (Image 15). The stormwater on the east side of the site flows to catch basins and one area drain. The rear drop off loop contains a catch basin as well. It appears that the roof drains capture all of the roof runoff.

Image 14: Typical catch basin

<i>Specific Issues</i>	<i>Recommendations</i>
The existing drainage system does not meet current Massachusetts Department of Environmental Protection (MADEP) Stormwater Standards.	Provide new drainage structures and pipe including water quality structures, review overall drainage system for the site

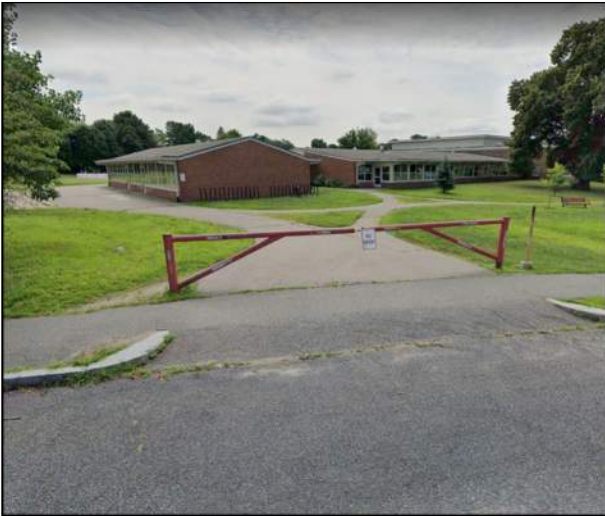
Image 9: Emergency access from Broad Meadow Rd.

An emergency access drive from Broad Meadow Road (Image 9) provides vehicle access to the north side of the building and site. Approximately 30% of the building is accessible by emergency vehicles. A paved sidewalk loops the south side of the building (Image 10) and connects to the bus loop. This pavement could provide access for emergency vehicles if it were made wider.

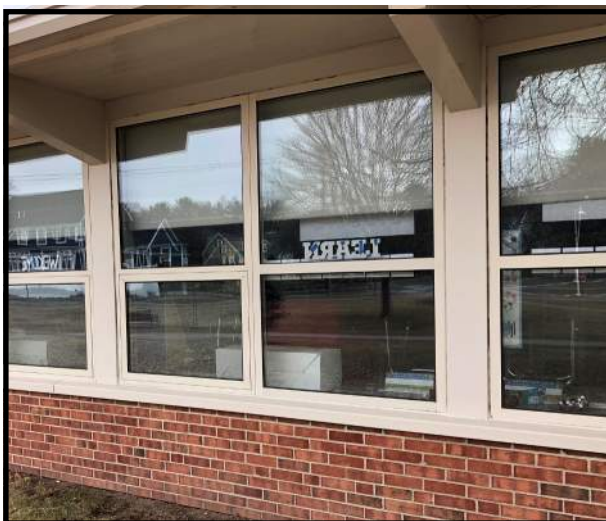
Image 13: Typical windows

The primary exterior window type is aluminum with insulated glazing with operable sections in curtain-walls and in punched openings. The windows as a whole are in good to excellent condition as they were installed in 2003 as part of the comprehensive addition / renovation.

<i>Specific Issues</i>	<i>Recommendations</i>
None	Continue to maintain hardware, caulking, and backer rod assemblies as part of an ongoing maintenance program

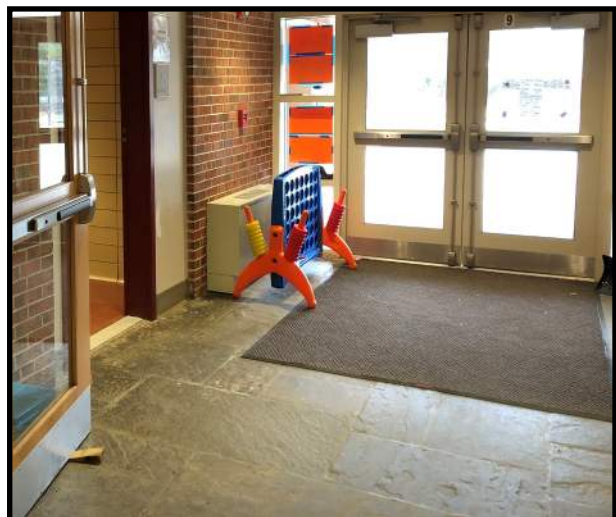
Image 6: Stone flooring at entrance

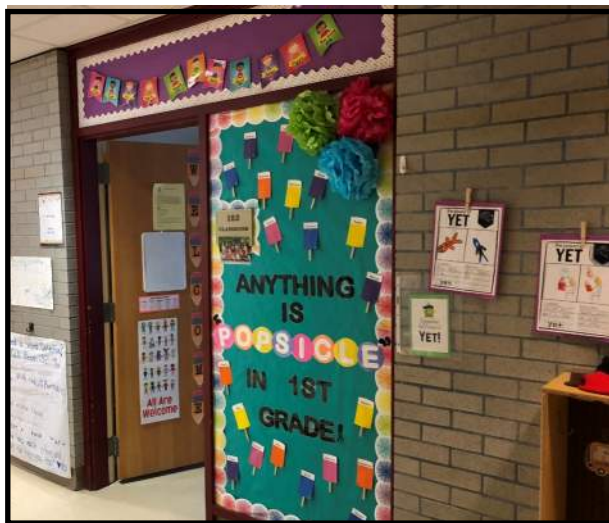
Several corridors have exposed brick walls (Image 13). Most of the brick is in good condition with some locations of staining (Image 14).

Image 13: Brick walls in corridor

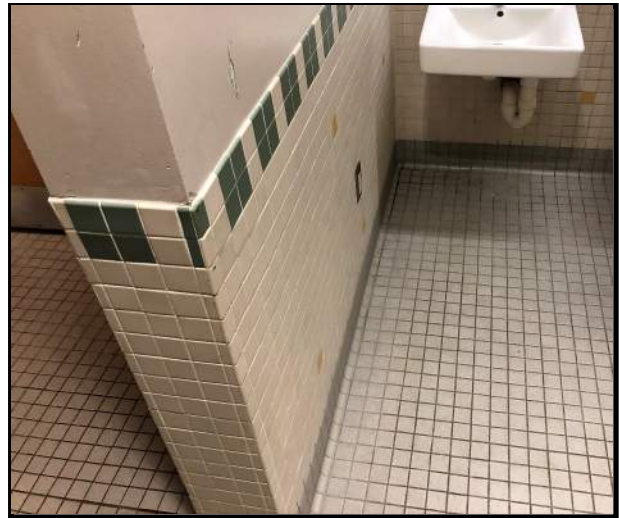
Image 8: Ceramic tile in restroom

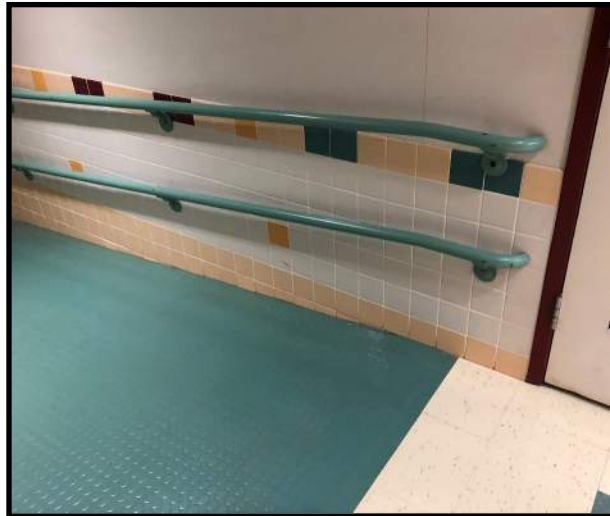
Image 9: Raised rubber flooring at ramp

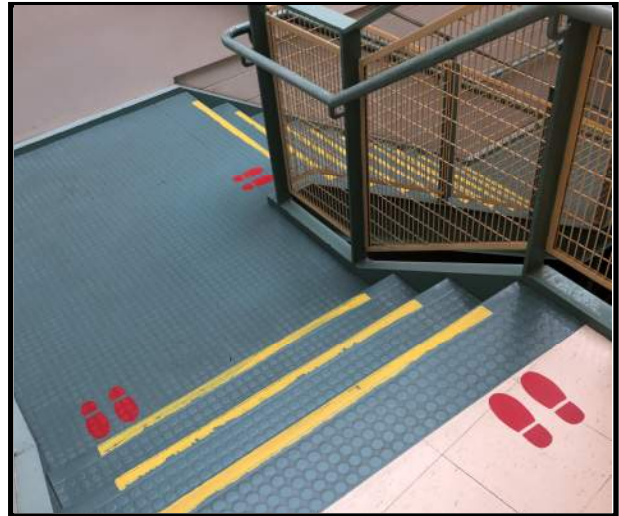
Image 10: Raised rubber flooring on stairway

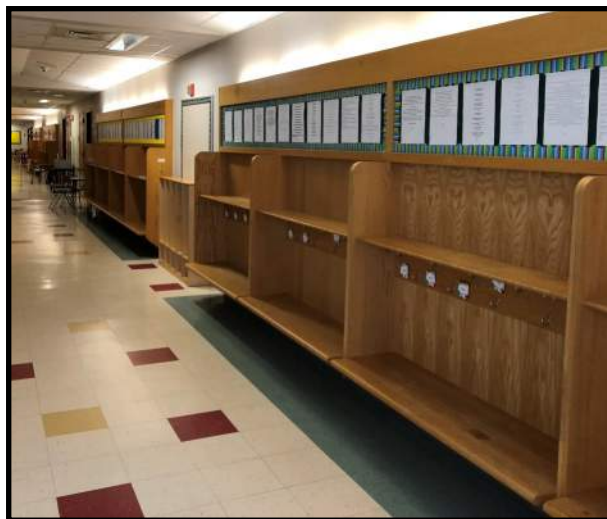
Cubbies are located in corridors and are in good condition (Image 27). Classrooms have built-in shelving with laminated tops along the window walls. These are in good condition.

Image 27: Student cubbies

<i>Specific Issues</i>	<i>Recommendations</i>
Student cubbies do not provide dividers between students belongings—this should be reviewed for health reasons.	Consider adding dividers between student belongings to reduce the transfer of lice and other health related issues

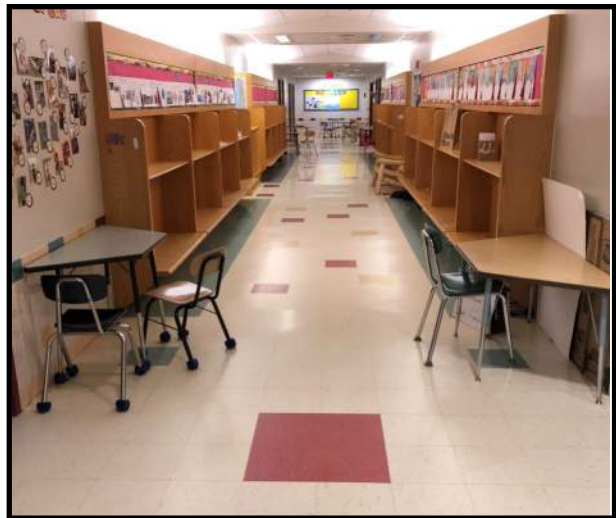
It appears that small groups and one on one tutorial sessions occur in the corridors. This is an indication that special education teaching spaces are missing or not located within the academic wing of the school.

Image 30: Teaching spaces in corridor

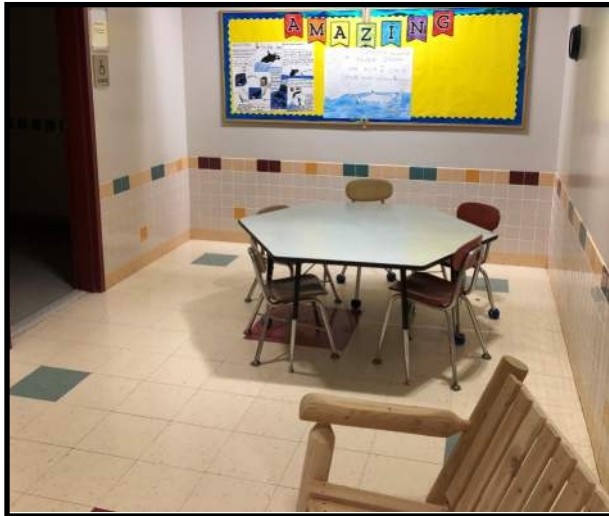
Image 31: Student learning area in corridor

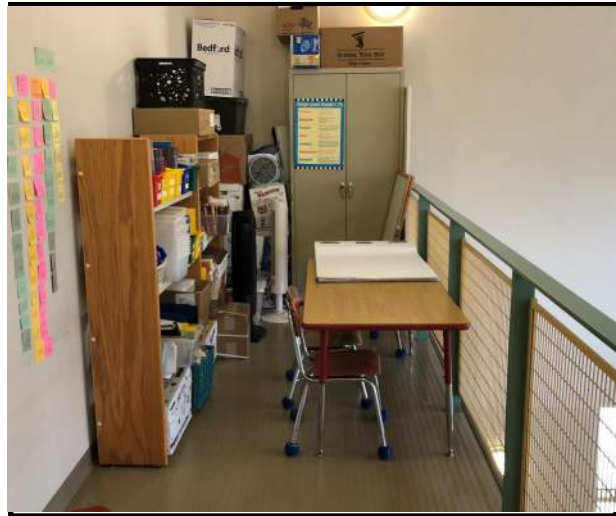
Image 32: Teaching area in stairwell

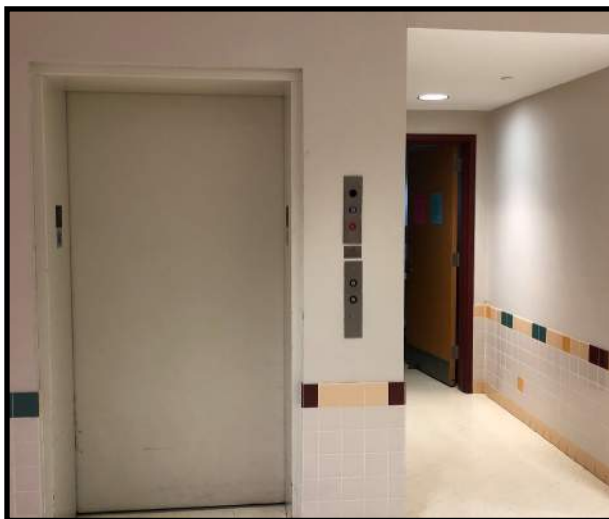
The school is equipped with an elevator that serves all levels. The elevator appeared to be in good working condition during the site visit.

Image 33: Elevator

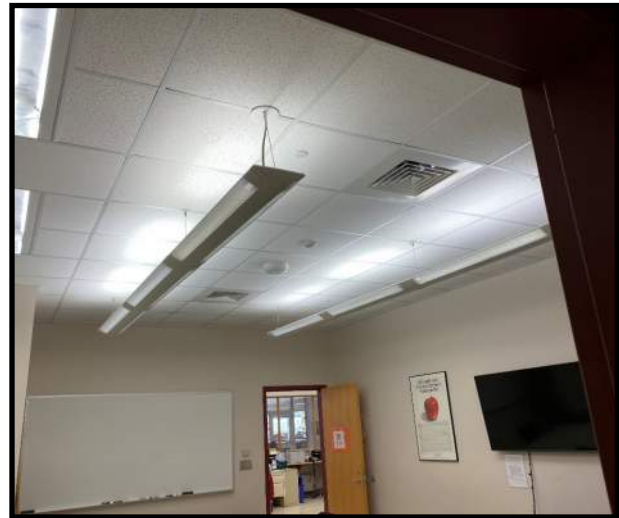
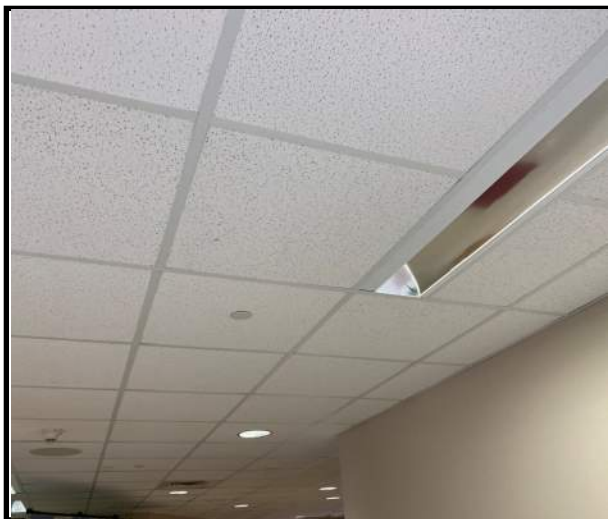
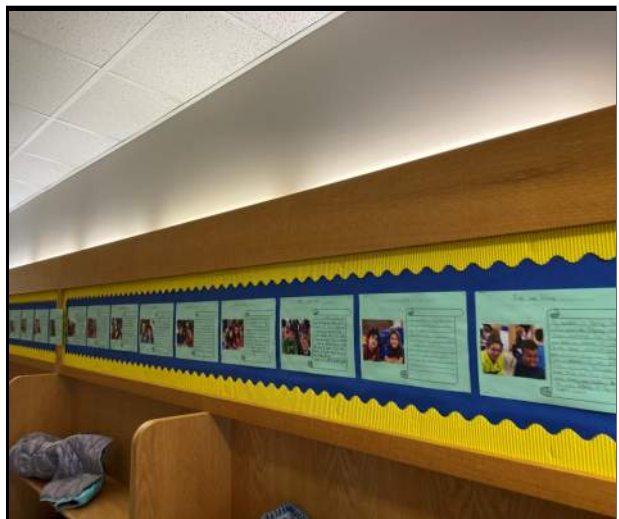
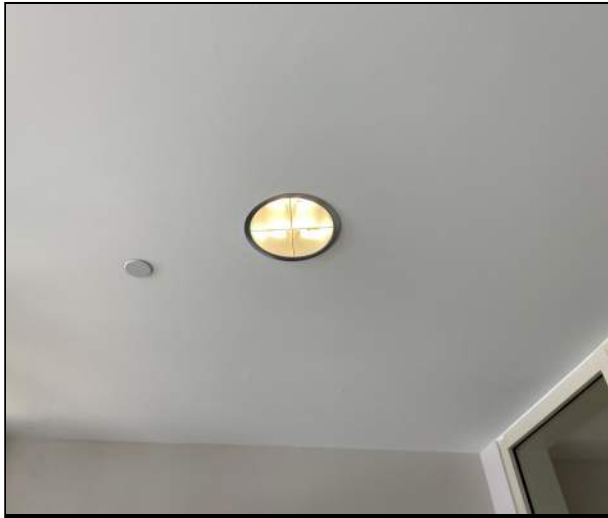
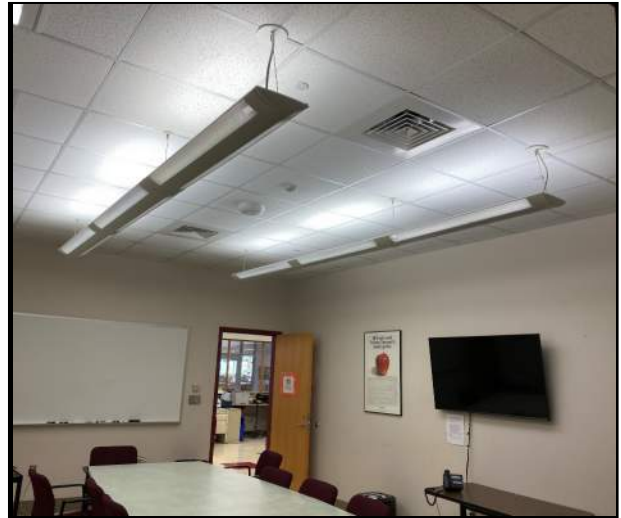
<i>Specific Issues</i>	<i>Recommendations</i>
Lighting levels are adequate for classrooms and offices. Fixtures look to be in good condition but the fixtures are inefficient fluorescent lamps. (Image 9) (Image 10) (Image 11) (Image 12) (Image 13)	Lighting throughout the building should be upgraded to energy efficient LED lighting
Lighting controls are provided by line voltage occupancy sensors and toggle switches. There are no photo sensors, dimming switches or centralized controls. (Image 14) (Image 15) (Image 16)	Provide an automatic lighting control system(ALCS) with vacancy and photo sensors, dimming controls, and centralized management
Some exit signs are nearing the end of their serviceable life. (Image 17)	Replace older exit signs with new LED exit signs
Exterior lighting pole mounted fixtures and building mounted sconces are in very good condition and appear appropriately spaced in walk-ways and parking areas. At time of visit it was impossible to determine	Review lamping type for all exterior lighting fixtures and provide new energy efficient LED fixtures if needed.

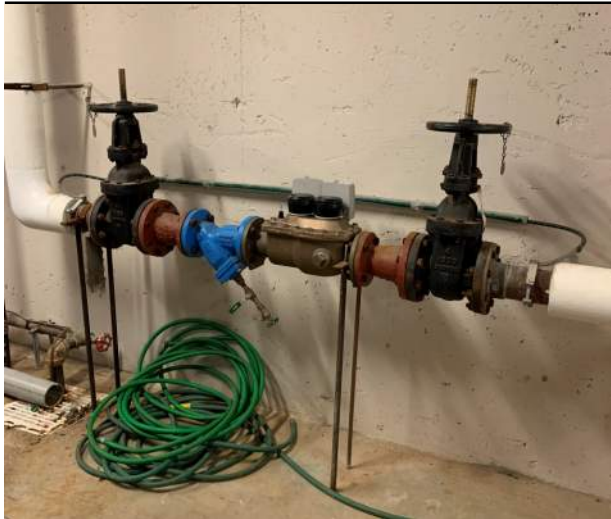
Image 7:

The main domestic water service is located in the Ground Floor Mechanical Room. The service is 4" in size and includes a 4" meter (Image 7). The main domestic cold-water distribution is 4" in size. The majority of the domestic distribution piping is located in the ceiling of the ground floor throughout the facility.

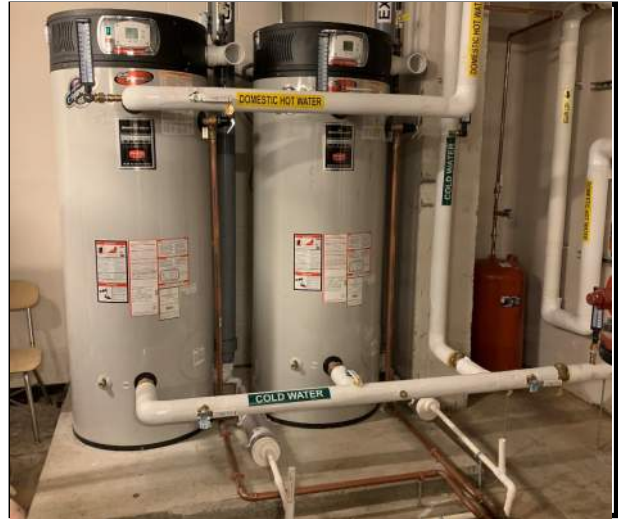
Image 8:

Domestic hot water in the building is generated through (2) two high-efficiency, gas-fired storage type water heaters (Image 8). The hot water systems are recirculated (Image 9). There are thermostatic mixing valves on the systems to prevent scalding (Image 10). Each water heater has a natural gas input of 300,000 BTUH and 100 gallon storage capacity. Water heaters are relatively new and in good condition.

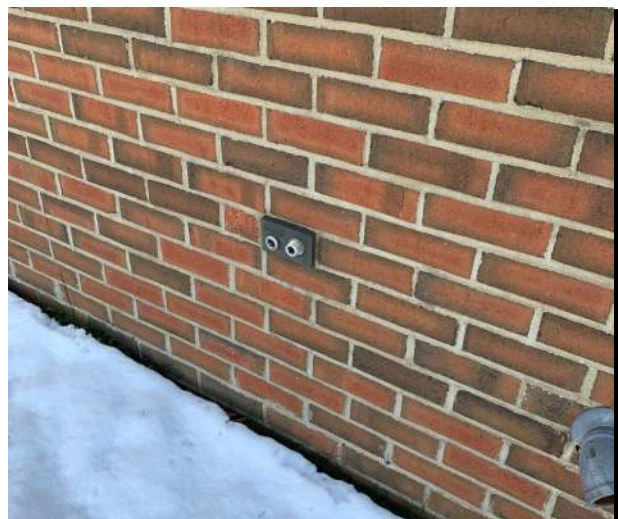
Image 12:

Wall hydrants with vacuum breakers are provided around the building's perimeter (Image 12).

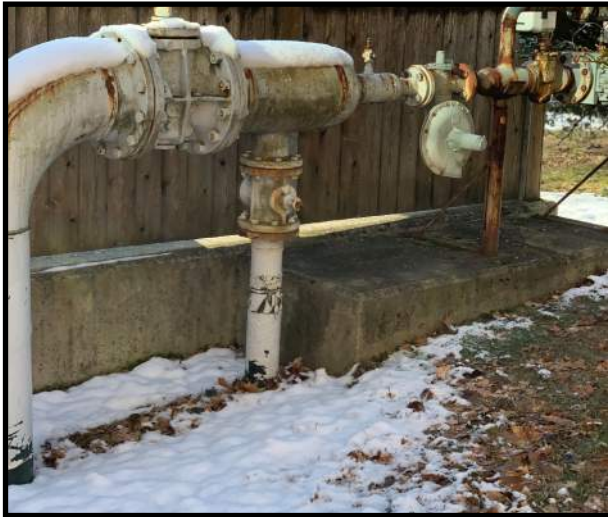
Image 13:

An elevated pressure natural gas service is supplied to the building. The exterior gas service includes a pressure regulator and gas meter at exterior wall (Image 13). Natural gas is distributed throughout the building from this location to the boilers, rooftop heating equipment, domestic water heaters, kitchen equipment and gas emergency generator (Image 14).

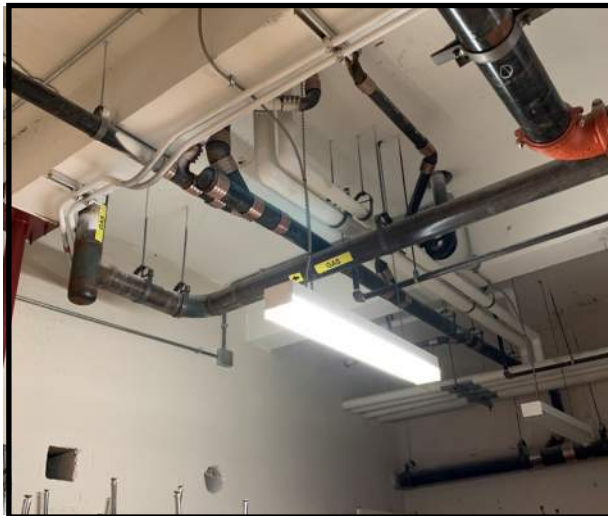
Image 15:

Cast iron is used for sanitary and storm drainage. Where visible, the cast iron pipe appears to be in good condition. Smaller pipe sizes appear to be copper (Image 15).

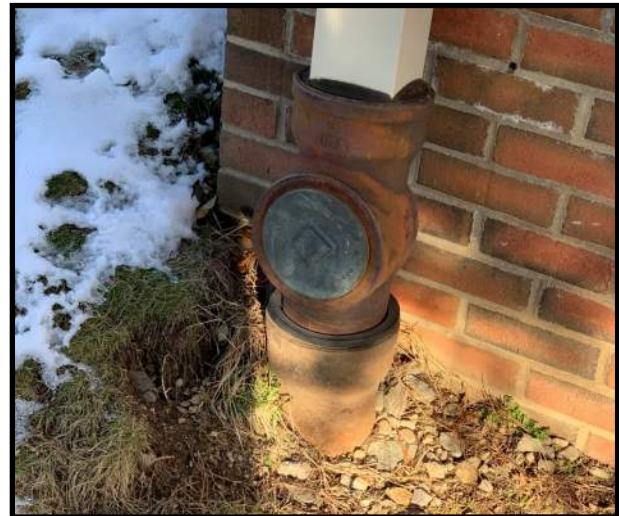
Image 16:

Roof drains are located throughout flat roof areas. The horizontal storm piping which is collecting rain-water from roof drains is insulated. In addition to an interior roof drainage system, some roof drainage is being directed by gutters and downspouts to the site storm system by downspout boots (Image 16).

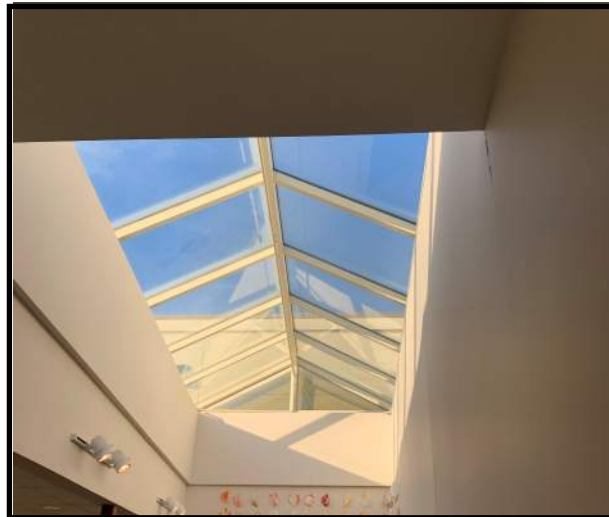
Image 3:

In areas of the school with no ceilings, sprinkler protection is provided by quick response upright sprinkler heads and sidewall sprinkler heads (Image 3). In locations where there is potential of damage to the sprinkler heads by a foreign object, sprinkler guards are provided. (Image 4). In areas of the school with ceilings, sprinkler protection is provided by quick response concealed pendent sprinkler heads (Image 5).
