## EXISTING CONDITIONS ASSESSMENT

## EXISTING SITE & BUILDING DATA

Nitsch Engineering has performed research of the existing site conditions for the Mitchell School at 187 Brookline Street in Needham, Massachusetts. Nitsch Engineering also conducted a site visit on December 13, 2019 to observe the overall site, take pictures and provide a preliminary outline of short and long term needs for the school. Nitsch Engineering included anticipated site permitting requirements for the Mitchell School for any proposed site work.

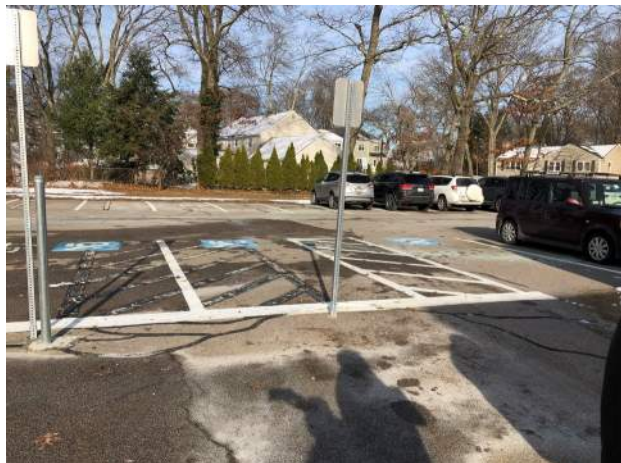
Image 10—Accessible Parking Near Playgrounds and Fields—North West of Building)

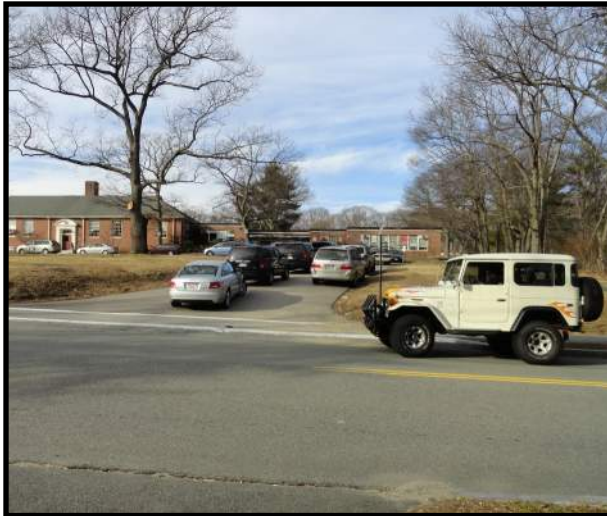
<i>Specific Issues</i>	<i>Recommendations</i>
Pavement in drop-off loop and parking areas is cracking and in need of repair	Mill and overlay pavement where cracking has occurred
Review the location of the accessible parking at the front of the building—the slope of the drive appears to exceed the allowable slope for accessibility	Determine locations other than the current location that are better suited for accessible parking
Accessible parking on the north side of the building is not located near the entrance	Review the paved area near the north side of the building for appropriate accessible parking
Site safety and parking capacity	Review site circulation and parking needs to look for ways to optimize on site queuing for pick up and drop off and increased parking

Image 2: Front entrance drop-off loop

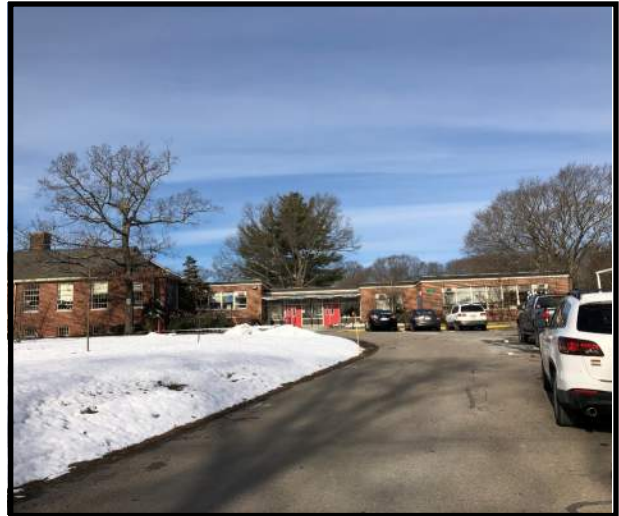
Image 3: Front entrance drop-off loop

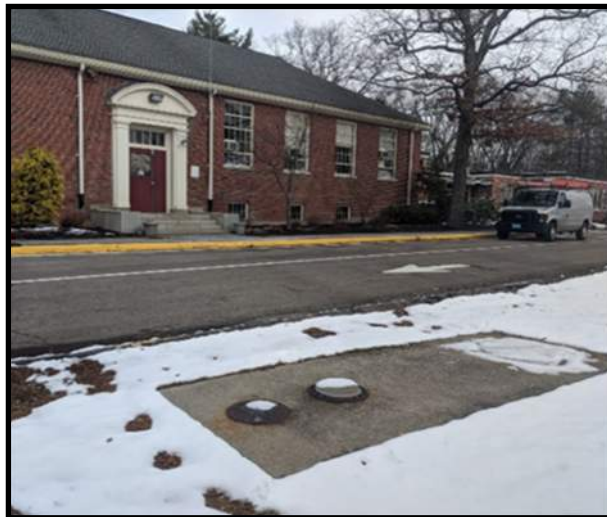
Image 4: Front entrance drop-off loop

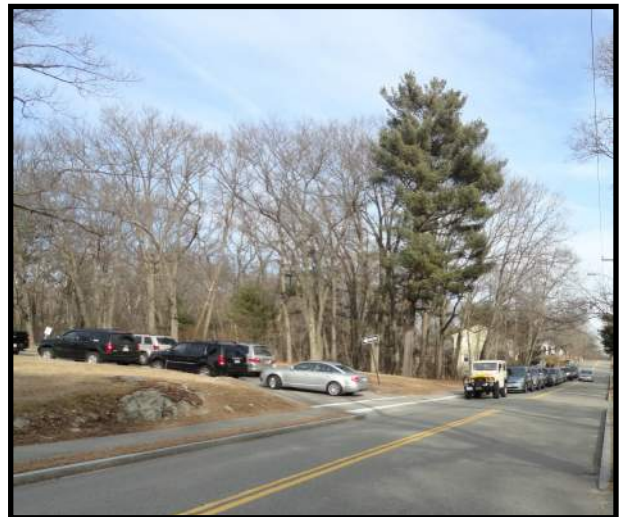
Image 5: Cars queued along Brookline Street

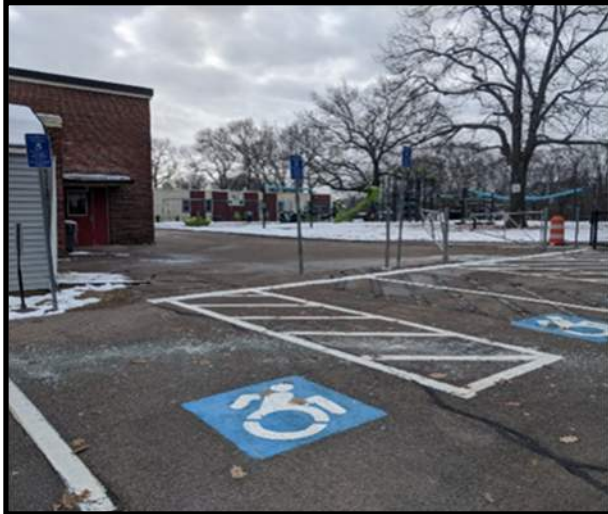
Image 9: North parking lot with HC parking

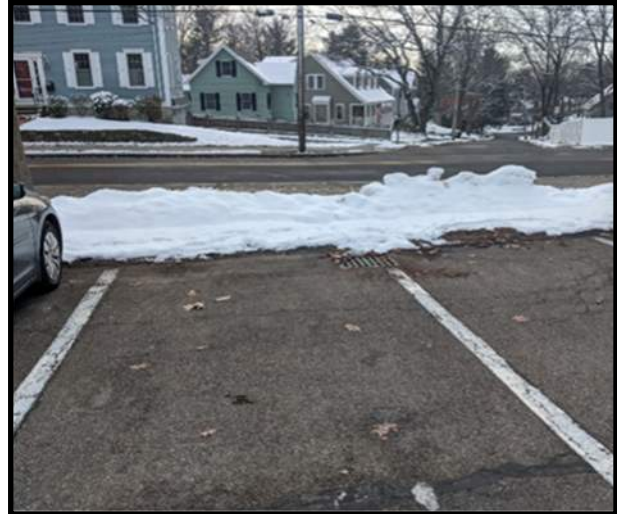
Image 10: Drainage in front parking lot

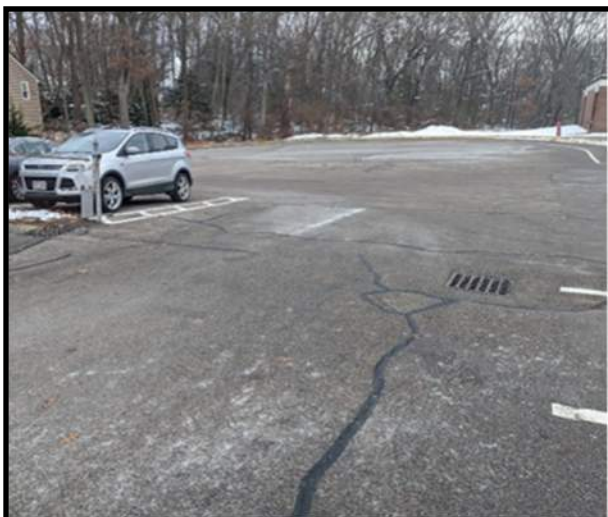
Image 11: Drainage in north parking area

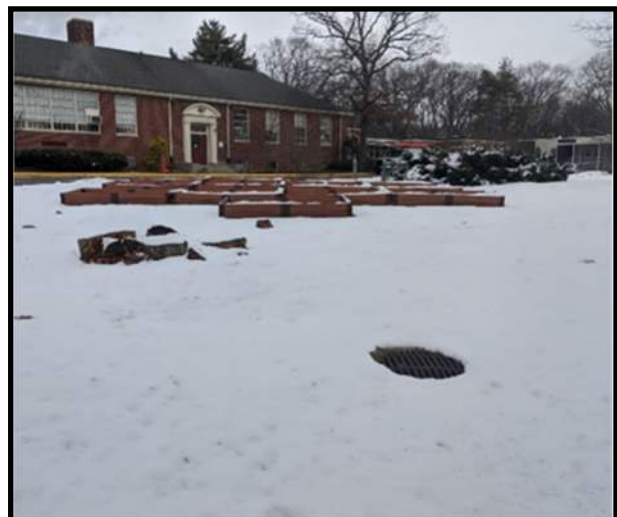
Image 12: Drainage at green space in front of build-

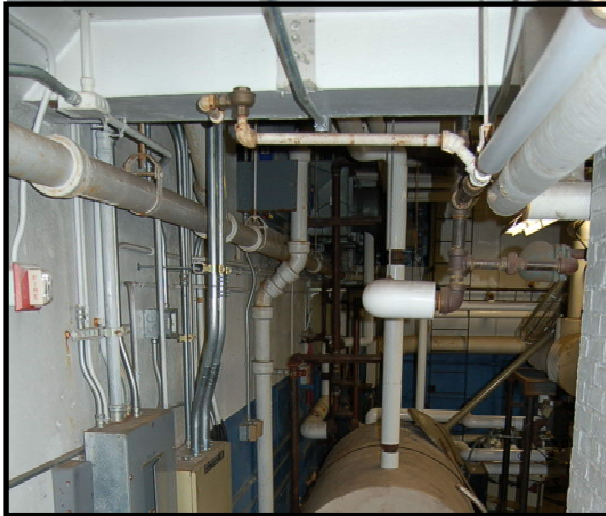
The single story building has a crawl space and a lower level at boiler room and storage areas (image 1 & 2). Foundations are traditional, cast-in-place concrete with interior pilasters on footings and concrete walls at the exterior. The first floor level is cast-in-place flat concrete slab construction supported on the pilasters and on steel concrete encased beams above the occupied lower areas. 8" interior wide flange columns and exterior masonry walls support steel framing at the attic level consisting of wide flange beams and bottom chord of steel trusses. Roof framing has the trusses with 8" and 10" steel purlins. The roof substrate has 1 ½" wood plank spiked to purlins and trusses (image 3). There is a slab at the ceiling level (fan room) which has cast-in-place concrete supported on steel beams. Exterior walls appear to be solid brick with steel lintels supporting veneer. There is interior masonry steel stud with plaster.

Image 1: Exterior wall and structure at boiler room

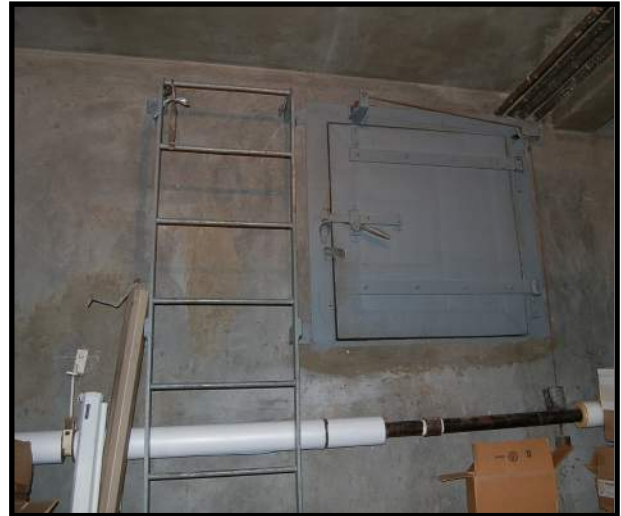
Image 2: Access to crawl space

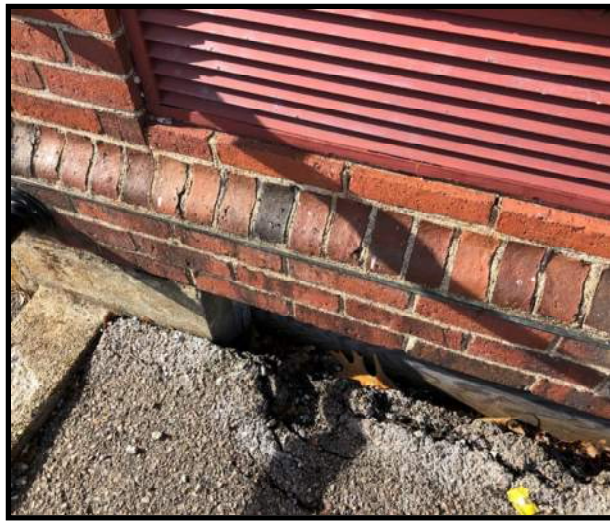
Image 2: Former window or vent filled with plywood

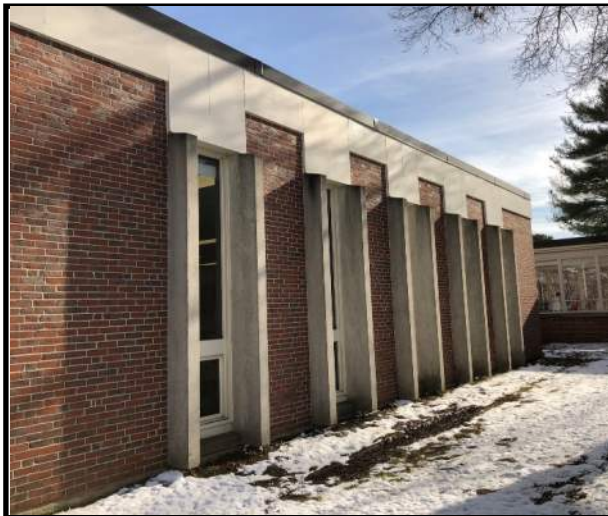
The exterior walls of the main building are primarily constructed of brick veneer with masonry back-up walls. The 1968 addition includes a pre-cast concrete band below the roof edge and window fins for daylight control (Image 8). In general, the brick is in good to fair condition throughout. The oldest portion of the building has bricks that are in fair condition. There are areas where the bricks have cracked, or have damage that appears to be from an impact load (Image 9). The 1948 portion of the building has a brick water table (Image 10). Many of these bricks, as well as the vertical wall in several areas, have loss or damage to the harder exterior surface (face) of the brick. The damage to this surface can expose the softer internal brick and lead to water absorption. Effloresces, mold and movement of brick, a result of water or moisture infiltration, can be seen in many areas around the building (Image 11).

Image 8: Pre-cast concrete fins at 1968 addition

Re-grouting and repointing is needed throughout the building exterior. The expansion joint between the 1958 kindergarten addition and the original building is in need of repair with the appropriate expansion joint materials (Image 12).

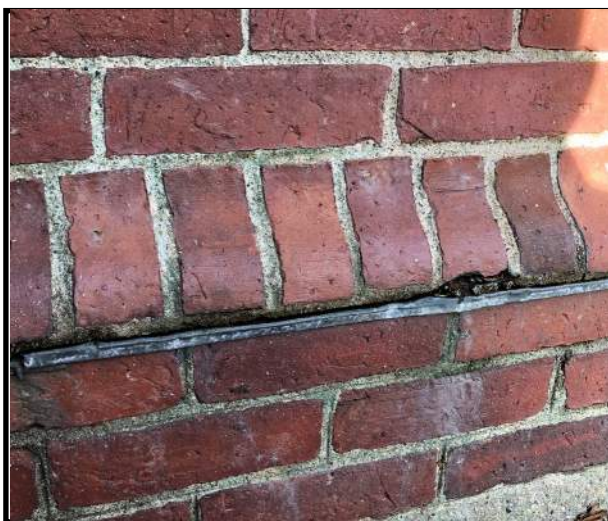
Image 10: Brick watertable

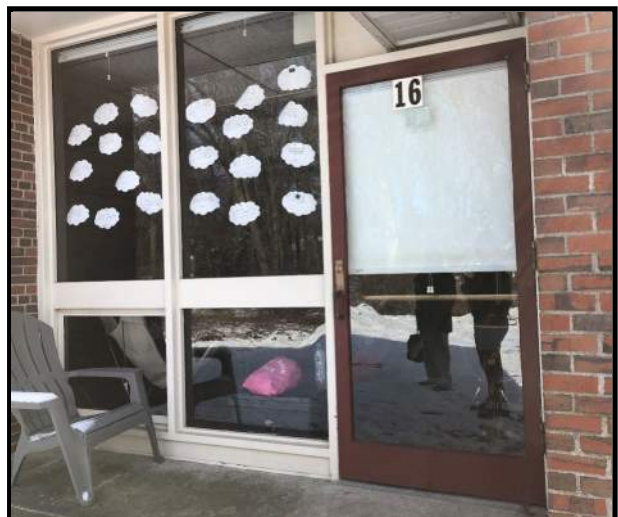
Door types include hollow metal, wood, storefront, steel framed glazed units and some recent replacements appear to be insulated hollow metal with and without vision lites. Many of the original exterior doors have been replaced with new doors and hardware. Most of these doors are in good to fair condition. Doors that were not replaced (Image 15) are in poor condition and do not have ADA / MAAB hardware. The replacement doors were set into the existing frames which are in poor to very poor condition. The replacement doors do not fit properly in the old frames leaving gaps. Most of the metal door frames are rusting (Image 16) and the wood frames show signs of rot at the base. Many doors do not have the proper weather stripping, leaving large gaps for air flow around the doors. Several doors do not latch properly making them unable to be secured properly. This condition will also cause the doors to warp over time. Access control monitoring in the main building is located at the front entrance only. Security access control is located in both of the modular buildings. In most locations there are no vestibules or airlocks, creating significant energy losses. Many classrooms have direct access to the exterior (Image 17).

Image 17: Original 1968 door in classroom

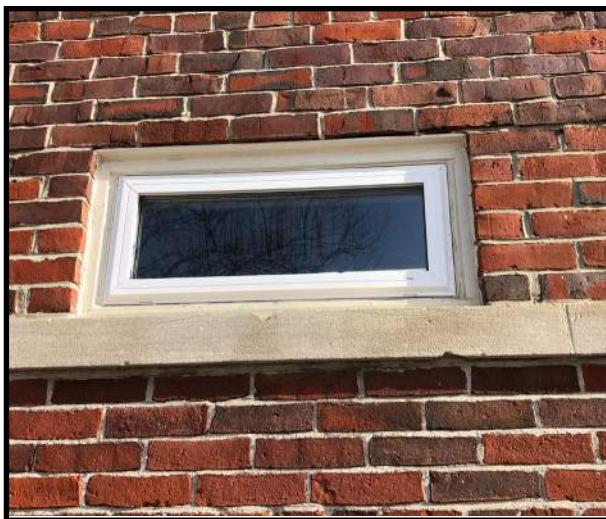
Windows located in the 1948 building are wood double hung or have hopper style bottom vents (Image 18). In the 1958 portion of the building the windows are steel sash / hopper style venting (Image 19) and the 1968 addition has steel frame windows with hopper style venting at the bottom (Image 21) or fixed panes. Window frames in general are in fair condition. Several windows are located close to grade, these wood window frames show signs of rot while the metal ones are rusting. There is a row of new residential quality casement style hopper windows at the end of the gymnasium (image22). A staff member reported that one of these windows fell out last year.

Image 22: Replacement casement window in gym

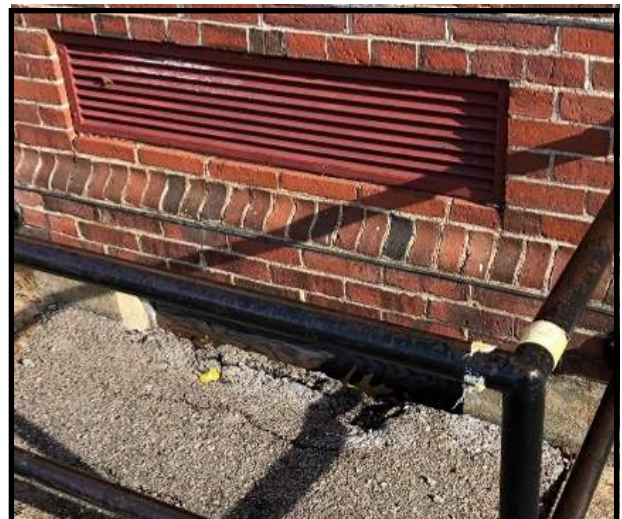
Window wells on the west side of the building have been filled in with asphalt or concrete with the screen and glazed window left in place (Image 23). This is an improper method of filling the window well and can lead to additional issues as water and snow seep between the window screen and window frame causing rust and rotting of the existing window frame.

Image 23: Sealed basement window and mech vent

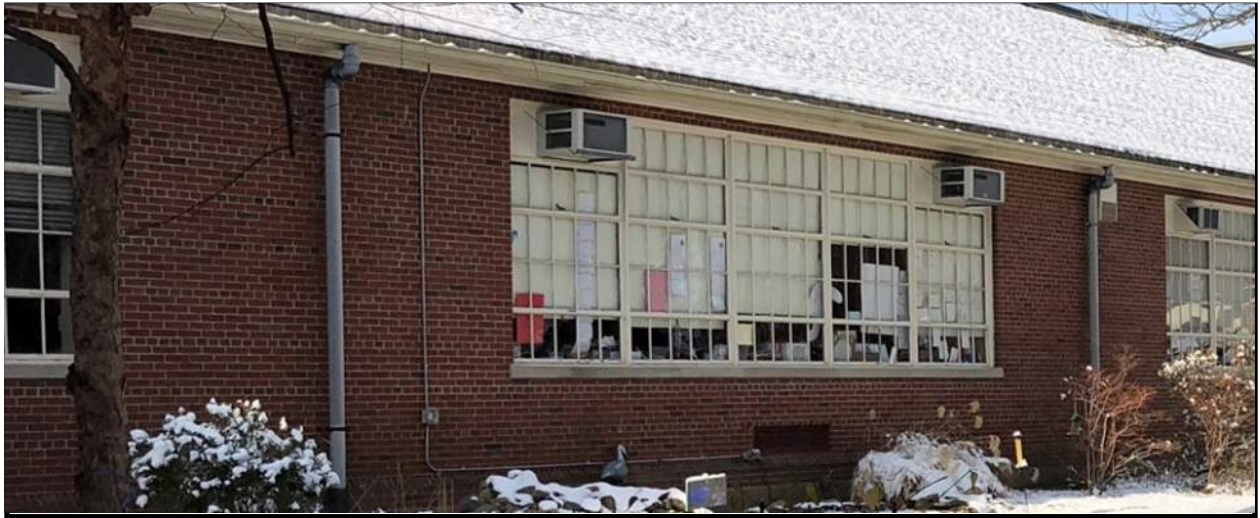
Image 18: Windows in 1948 wing (courtyard side)

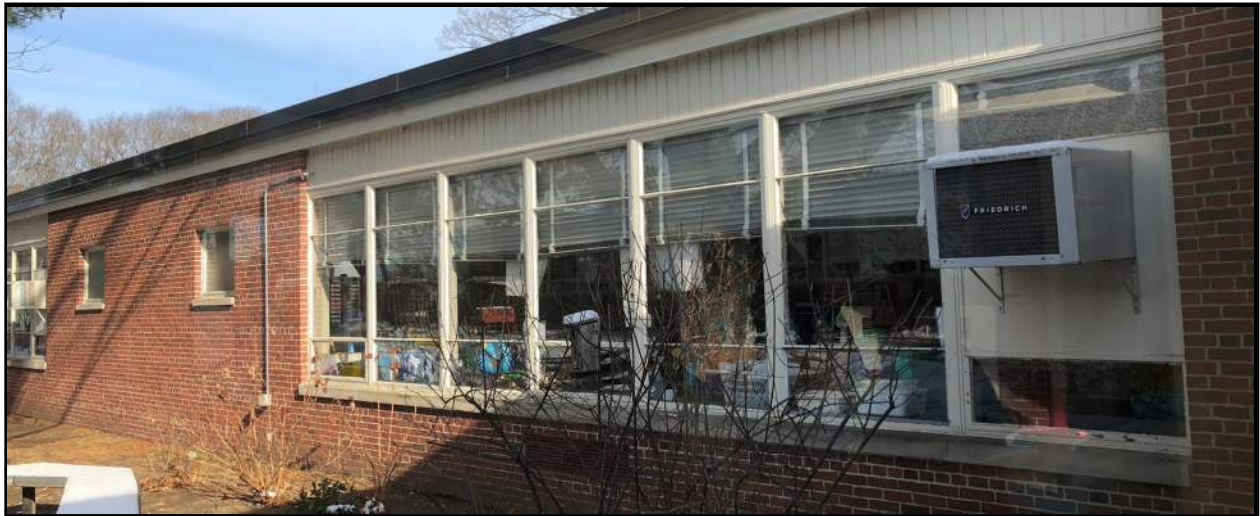
Image 19: Windows in 1958 wing (courtyard side)

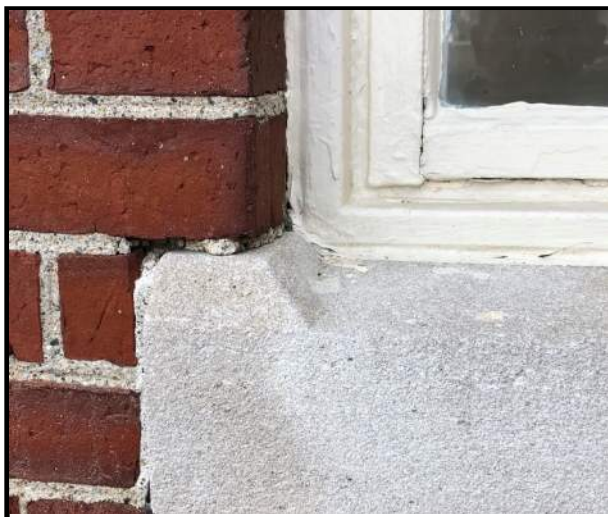
Image 20: Wood window frame

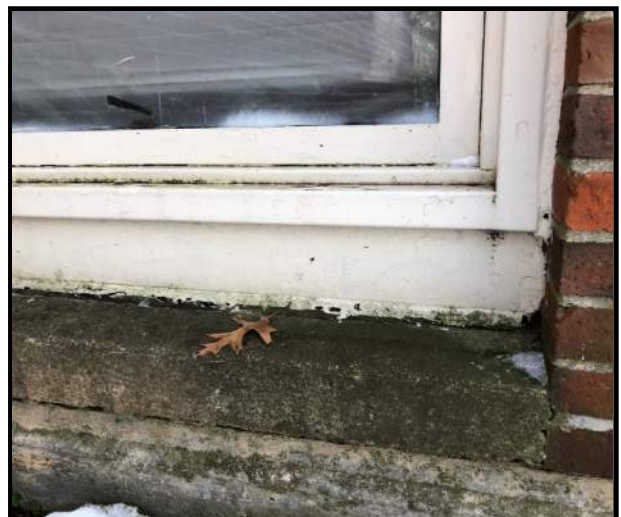
Image 21: Windows placed closed to grade

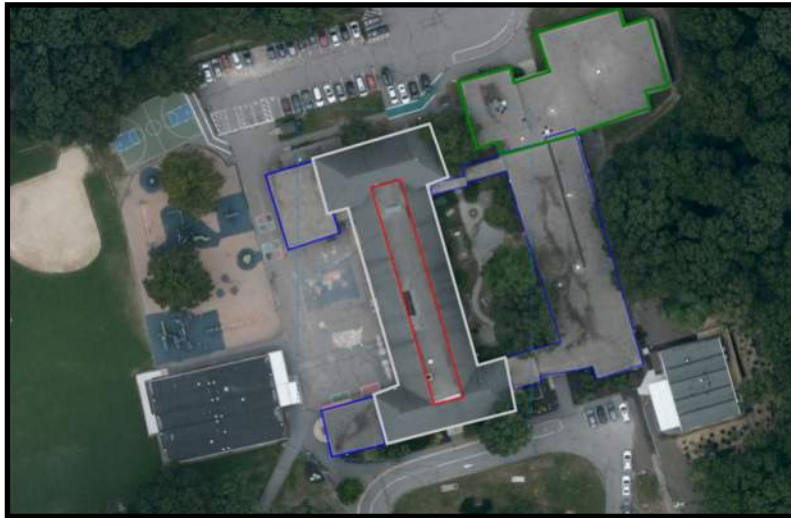
The roof of the 1948 building (outlined in white in Image 26) is mainly a pitched steel frame structure with tongue and groove wood sub structure (Image 27). Architectural shingle roofing material is used on the sloped sections with asphalt built-up roofing in the flat center portion (shown in red in image 26). There is some ponding or standing water at the edges of the flat roof area, and areas where the roofing material is showing signs of age and cracking (Image 29).

The 1958 (shown in blue in Image 26) and 1968 (shown in green) buildings have flat built-up roofs with internal drains. Ponding was not visible on these roofs at the time of our visit.

Image 26: Roof plan

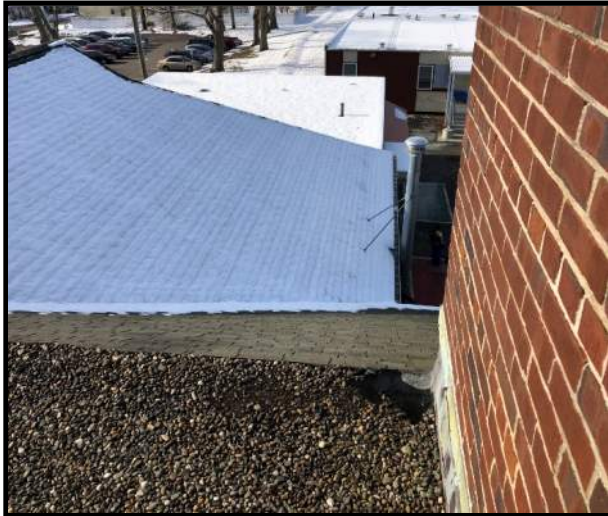
Image 29: Ponding at corner

<i>Specific Issues</i>	<i>Recommendations</i>
Ballasted built-up roofing is beyond serviceable life in many areas.	Replace flat roof systems as part of a roof—or an entire facility envelope renovation project.
Roof flashing and sealants missing or damaged.	Remove damaged, worn, and loose flashing materials and reset, replace, and / or re-seal as needed throughout.
Patched and re-patched areas of flat and low-slope membrane roofs in poor condition.	Replace flat roof systems as part of a roof—or an entire facility envelope renovation project.
Inadequate insulation in sloped roof areas	Shift the location of the thermal envelope to the roof level to provide a continuous thermal envelope and insulate the transition from the wall to the roof.
Gutters and downspouts are filled with debris	Clean and maintain gutters to avoid water overflow and ice damming

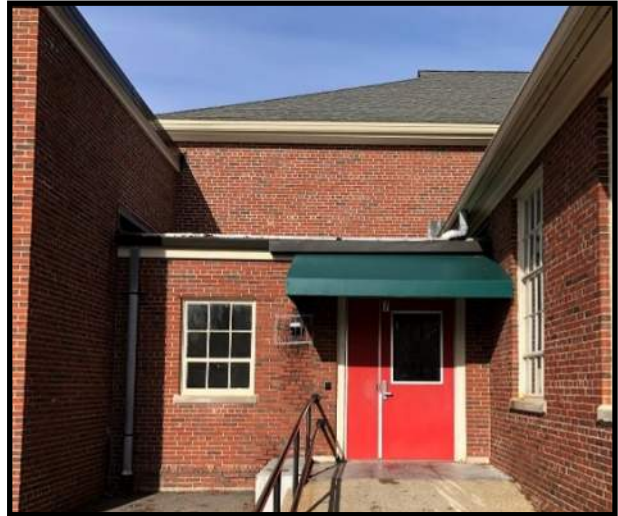
An area of concern is on the west side of the building near the entrance / exit to the playground. The sloped roof drains, via gutter and downspout, to the lower roof over the entrance. The gutters often fill with leaves (Image 28 & 30) and it was reported that water in this area falls onto the exterior landscaping and seeps back into the building causing pooling and flooding inside the building hallway. The smaller roof overhang at the gymnasium door also had standing water at the time of our visit.

Image 30: Sloped roofs draining to lower flat roof

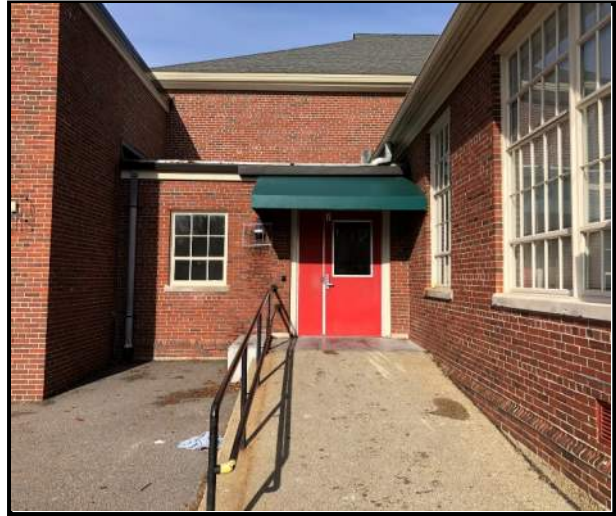
A non-conforming ramp is also provided on the west side of the building (Image 38) and provides access to the playground from the main level of the main building. This ramp provides the only direct access to the playground. Handrails are required on both sides of a ramp and extensions of 12" beyond the landing is also required.

Image 38: Ramp to playground

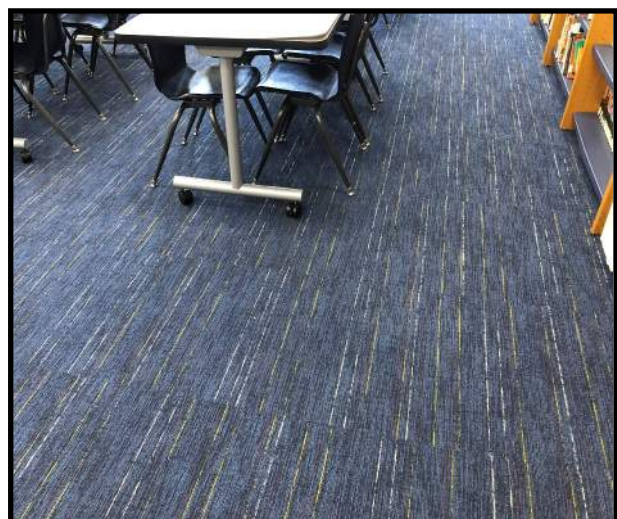
Image 6: Carpet in Library / Media Center

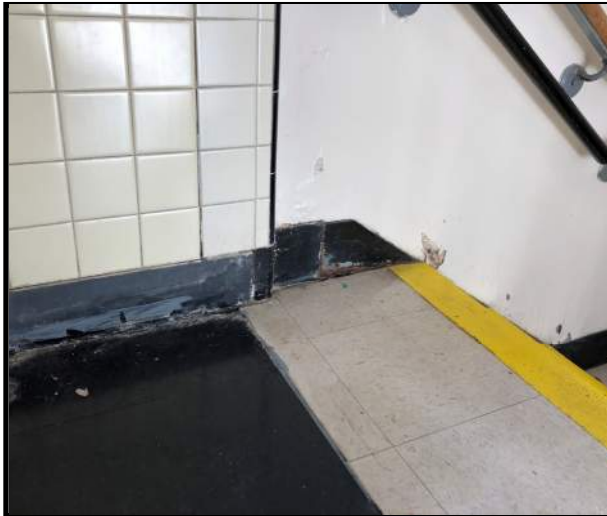
In the 1958 stairwell to the gym the plaster wall adjacent to the stairs is damaged and in need of repair and repainting (Image 17).

Image 17: Wall at stair way to gym

<i>Specific Issues</i>	<i>Recommendations</i>
Glazed CMU appears dirty at the base in many areas	Clean block and grout, consider applying a darker finish to the base block to avoid discoloration
Damage to wall adjacent to stairway	Repair base. Patch and paint wall, consider more durable finish such as tile or laminate
Folding partition walls do not provide sound absorption	Replace folding partition with permeant walls that reduce sound transmission

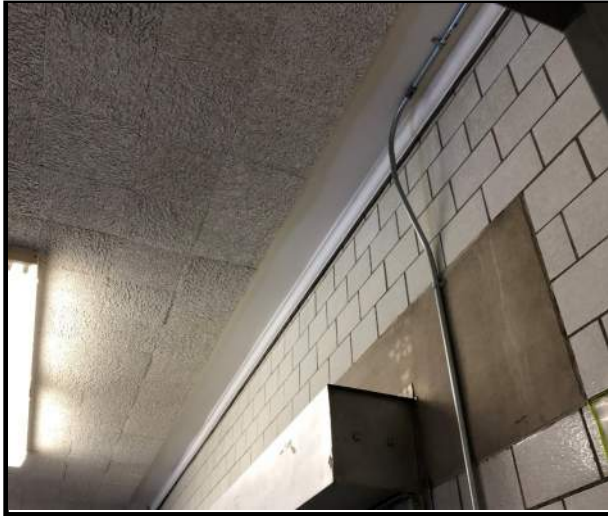
Perforated ceiling tiles remain in a few areas, some of these are badly damaged, broken, or sagging. A similar tile (non perforated) exists in the kitchen area. These tiles are non-scrubable and not compliant with current codes for kitchens.

Image 23: Non-perforated 12 x 12 ceiling tiles

<i>Specific Issues</i>	<i>Recommendations</i>
Stained, sagging or damaged ceiling tiles	Remove damaged tiles and locate the source of the staining (equipment, pipes, roof, humidity) repair source of damage and replace ceiling tiles
Missing or broken ceiling grids	Replace missing and broken ceiling support grids
Non scrubable 12x12 ceiling tiles in kitchen area	Remove existing tiles and glue (test for asbestos). Install drop in ceiling grid support and install ceiling tiles that meet requirements for kitchens
Dirty and dingy tectum ceiling panels	Replace tectum ceiling panels with acoustical ceiling tiles that do not collect dirt. Add acoustical wall panels if additional sound absorption is required

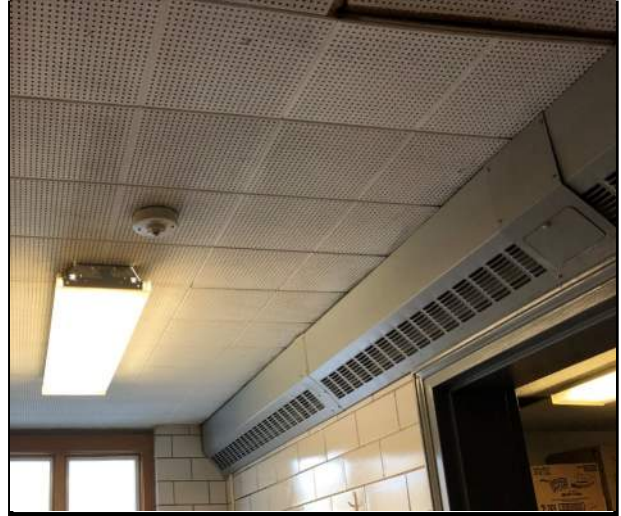
Image 24: Perforated 12 x 12 ceiling tiles

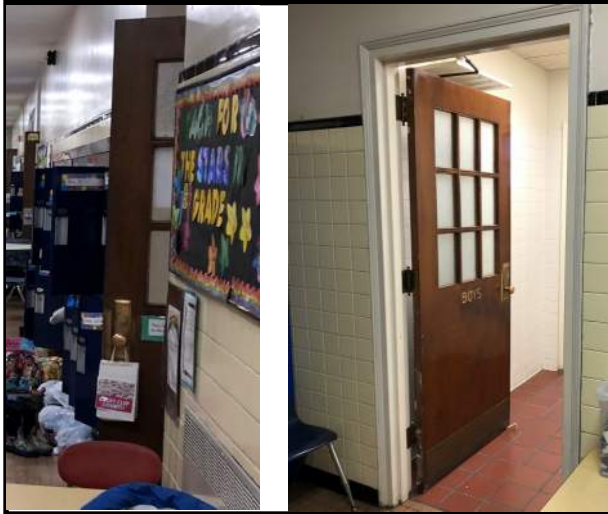
Interior doors in the 1948 wing are primarily solid wood with nine glazed panes in wood frames. This is typical for classrooms, corridors and multi-person use restrooms (Image 25). Most of these doors still have original hardware which is not ADA / MAAB compliant. Doors in the corridor are flanked by side-lights (Image 26) and transoms that have wire glass which was originally used to meet fire codes and is no longer compliant. These older doors are in fair to poor condition. Many need to be refinished and most require new hardware.

Image 25: 1948 Classroom &amp; Restroom Doors

<i>Specific Issues</i>	<i>Recommendations</i>
Wood doors show staining and age	Clean, sand, and re-stain wood doors
Non accessible hardware	Replace hardware on all doors that meet accessibility requirements
Push / Pull clearance at doors	Where possible remove adjacent walls to create clearance to meet accessibility needs. Alternative solutions, such as automatic door openers can be explored
Rusting hollow metal door frames, most likely due to cleaning around the doors	Sand and scrape rust from frames , repaint using a rust prohibitive paint
Wire glass at transoms and sidelights	Replace all wire glazing with tempered glass

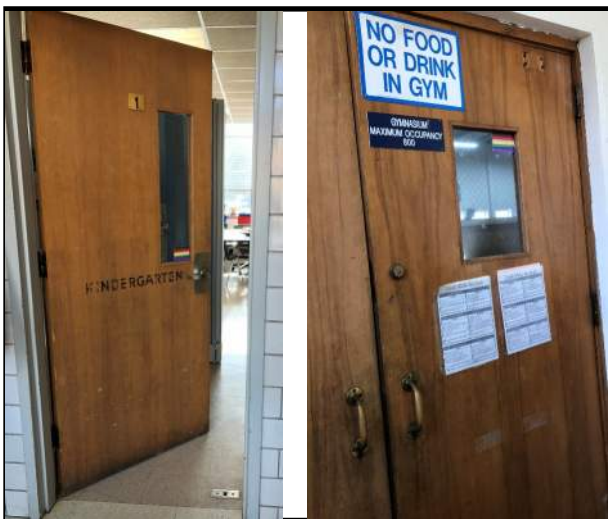
Doors in the 1958 section of the building are solid wood in hollow metal frames. Classroom doors have vision panels (Image 27) with wire glass. Non-classroom doors are solid or have vents in the bottom portion of the doors (Image 28). The corridor doors, side lights and transoms have wire glass as well (Image 28). Most of the hollow metal door frames are rusted at the base of the door.

Image 27: 1958 doors

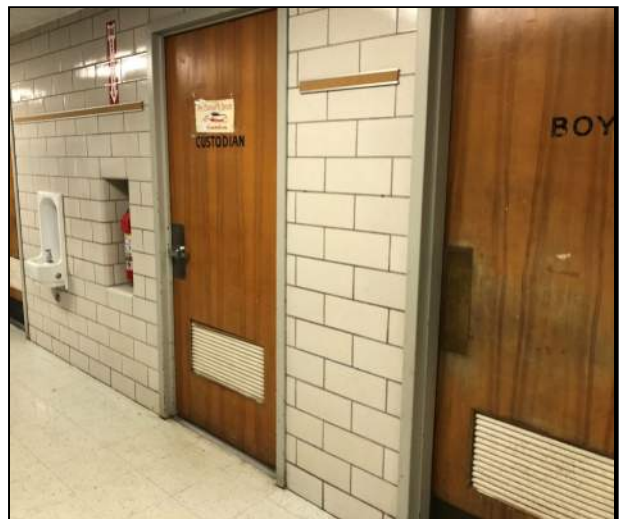
Image 28: 1958 doors

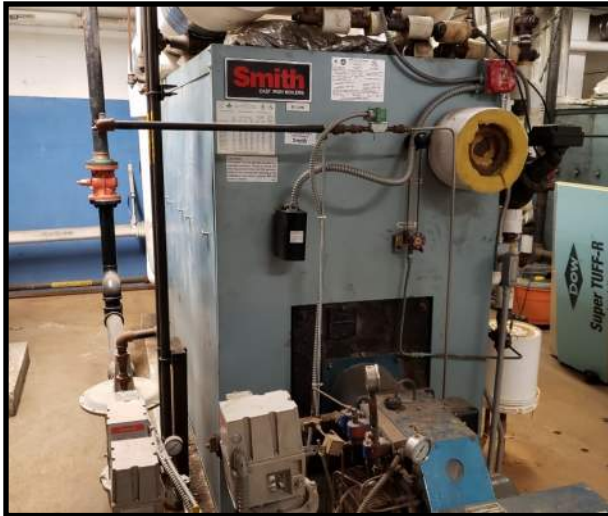
Image 1: Steam boilers

<i>Specific Issues</i>	<i>Recommendations</i>
Boiler #2 was not operating at the time of the survey; this boiler has surpassed its expected service life and is demonstrating failures.	Boiler #1 is approaching its expected service life of 25 years; the entire heating plant should be replaced with new high-efficiency hot water plant for increased efficiency, reliability, and controllability. This would require the replacement of all steam terminal units and piping throughout the building.
Steam was pouring out of the drip valve associated with the main condensate receiver; this indicates that steam traps somewhere in the building are not operating properly and require maintenance.	Service all existing steam traps and ensure proper working order; replace as-necessary.
There is not currently a low-space combustion air inlet, which is required by current codes in addition to the high-space combustion air inlets.	Direct vent a new hot water heating plant to eliminate the combustion air louvers, or add low-wall combustion air inlets sized appropriately to support the max plant firing rate.

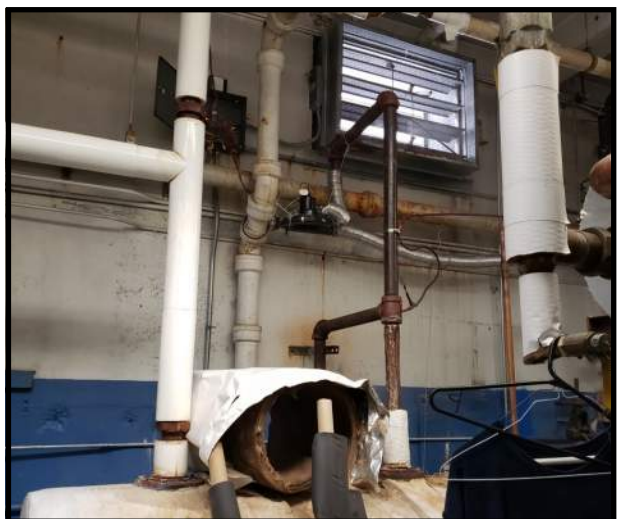
A combined Stainless steel vent system transfers the boiler flue gasses up through the roof via a masonry chimney. Combustion air is delivered to the boiler room via two (2) high-wall louvers (Image 6). A third combustion air inlet was sealed off and re-purposed as a relief vent for excess steam ducted from the condensate receiver with an inline fan (Image 7).

Image 6: Combustion air louvers

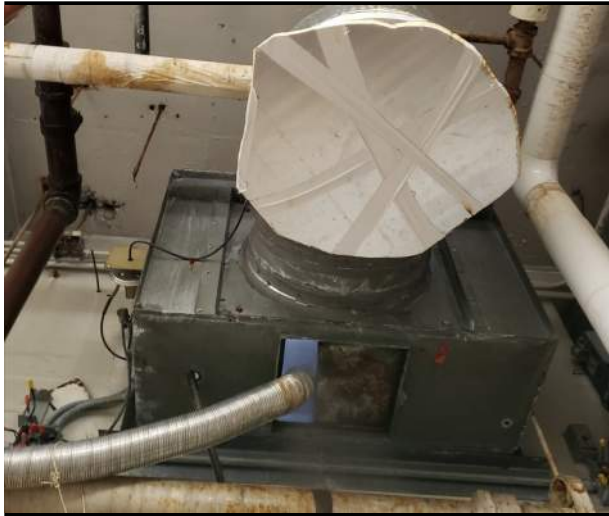
Image 7: Relief vent

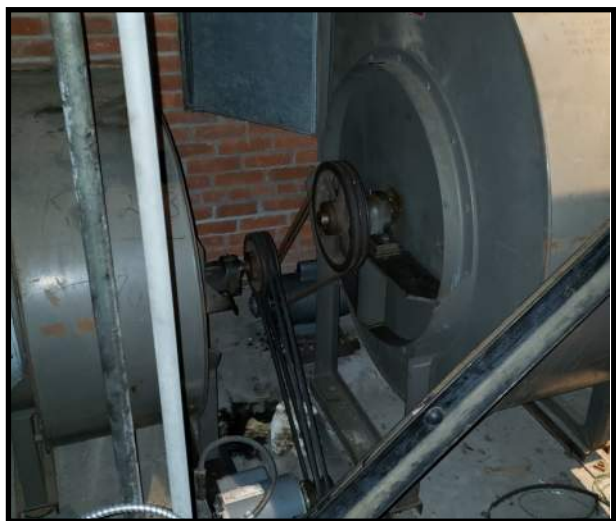
Ventilation for the building spaces is provided by steam and hot water unit ventilators communicating with exterior wall louvers. Attic-mounted exhaust fans provide code-required exhaust and general building pressure relief and communicate with a common exhaust outlet at a masonry penthouse above the roof consisting of multiple louvers; the attic is un-heated and un-insulated (Image 12).

Image 12: Attic exhaust fan

<i>Specific Issues</i>	<i>Recommendations</i>
Attic exhaust systems appear to be original to the 1949 building and have far-surpassed their expected service lives.	Replace existing attic-mounted exhaust systems in kind with new systems of similar type and capacity
All ventilation equipment appears to be original to the associated buildings and has far surpassed its expected service life of 20 years.	Verify size and replace (or enlarge where required) entire building ventilation system
Janitorial closets including chemicals and mop sinks do not have full code-required exhaust.	Verify dedicated exhaust systems for spaces used for the storage of chemicals and noxious materials. Enlarge or replace as required
The installed ventilation equipment for large spaces does not appear to be sized appropriately for the potential occupant load based on available floor area and potential seating arrangements.	Provide ventilation requirements to meet anticipated maximum occupant load in cafeteria and gym

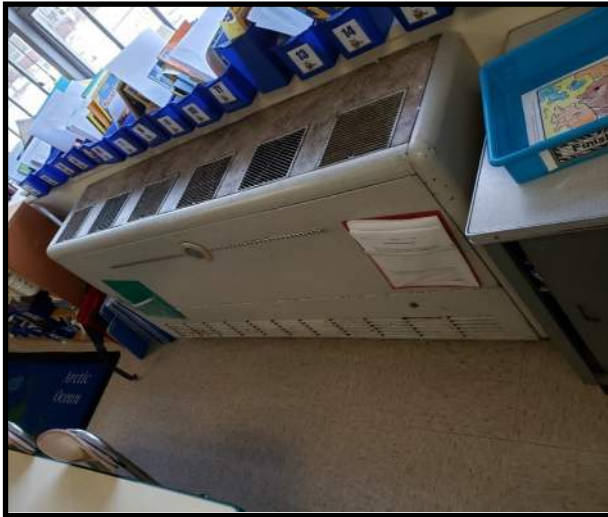
A high-space mounted unit ventilator provides heating and ventilation to the Gymnasium space; space pressurization is maintained by an attic-mounted exhaust fan in the adjacent storage room. Classrooms and exterior spaces alike are generally provided with vertical steam and hot water unit ventilators mounted on an exterior wall and communicating with an exterior wall louver; these units

provide heat and ventilation to the spaces served (Image 13).

Image 13: Classroom unit ventilator

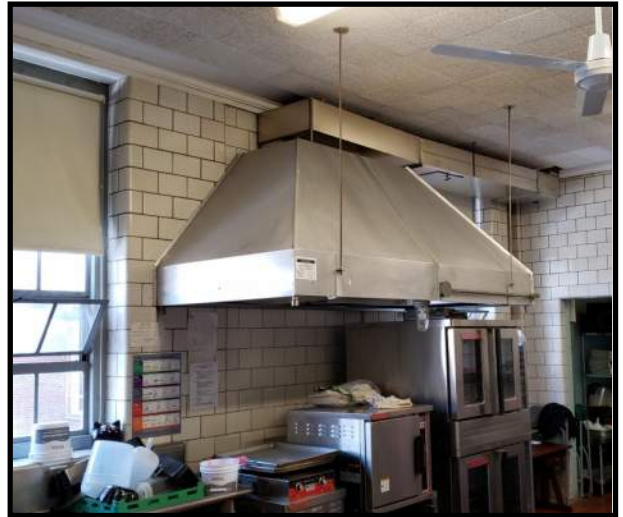
The Kitchen is provided with a range hood including cleanable grease filters and a roof exhaust fan (Image 14). Make-up air for the range exhaust hood is pulled through the servery from the cafeteria when the hood is in-use. The cafeteria is provided with an above-ceiling unit ventilator ducted to exterior wall louvers for ventilation and ceiling grilles to deliver heat and ventilation to the space.

Image 14: Kitchen range hood

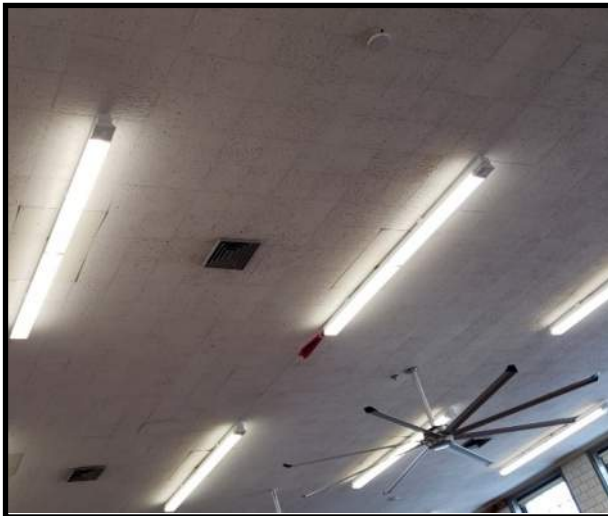
No air distribution was present for the stage within the cafeteria. A large ceiling-hung de-stratification fan is installed in the cafeteria to alleviate the stratification of hot air at the ceiling level and provide increased comfort levels for the space occupants (Image 15). An original fresh air supply and exhaust air system was not operating at the time of the visit.

Image 15: Cafeteria fans

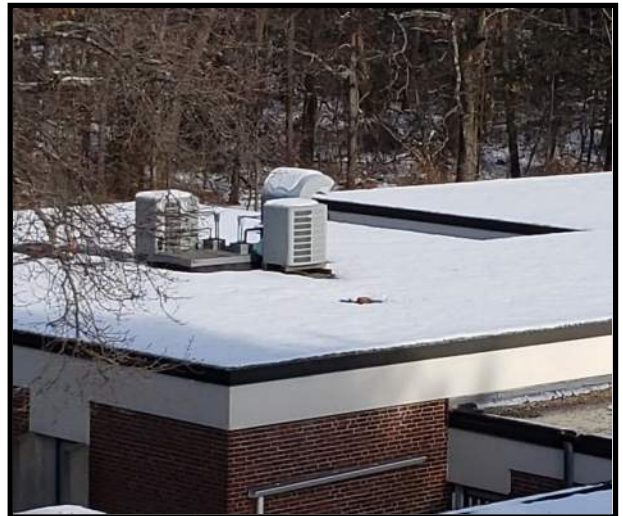
The media center includes dual above-ceiling air handling units with split DX coils and associated roof-mounted condensers. The media center air handlers communicate to a common ducted gooseneck above the roof level for ventilation purposes (Image 16). These media center air handling units provide heating, ventilation, and air conditioning to the space.

Image 16: Media Center air handler

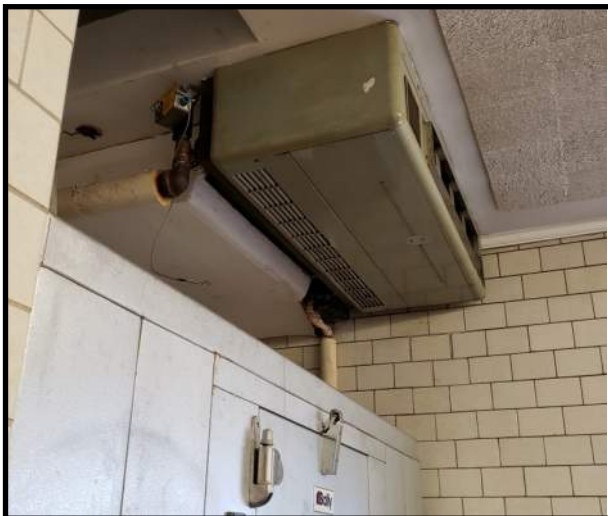
Image 17: Kitchen steam unit ventilator

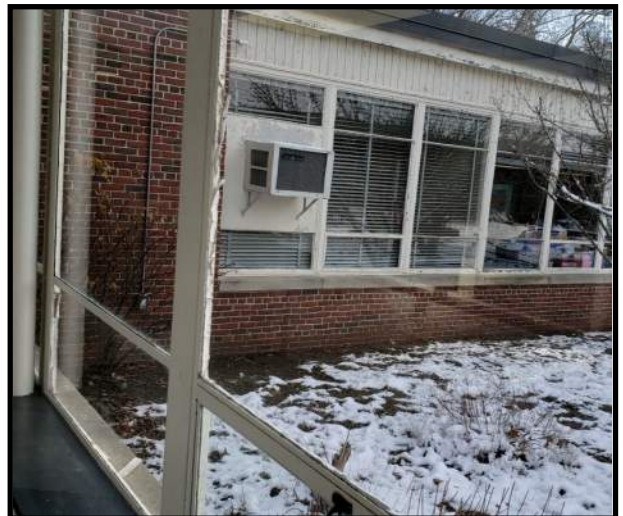
Image 18: Window AC unit

The building is not provided with a central cooling system. The media center air handling units include split DX cooling sections with roof-mounted condensers. Many classroom and office areas include through-window type air-conditioning units (Image 18).

<i>Specific Issues</i>	<i>Recommendations</i>
Window Air conditioners are undersized for classroom applications and are very inefficient in comparison with current technologies.	Remove the window A/C's and replace with current cooling technologies sized appropriately for the application.
Non-air-conditioned learning spaces generally have poor air quality and lead to lacking attendance and poor learning environments.	Provide a means of air-conditioning for all learning spaces.

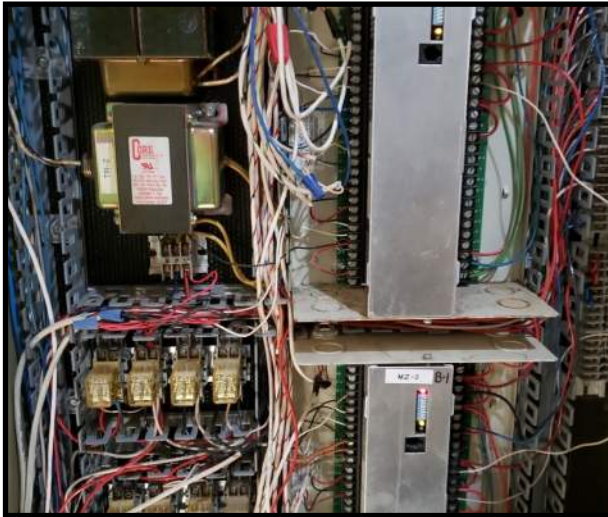
The majority of the building's HVAC systems are monitored and controlled by a direct digital central building control system manufactured by "Barber Coleman Company". The main automatic temperature control (ATC) panel is located in the old incinerator room adjacent to the boiler room (Image 19).

Image 19: ATC Panel

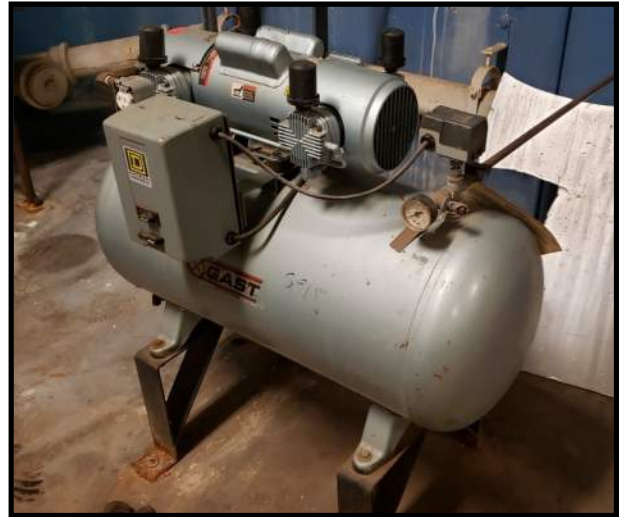
<i>Specific Issues</i>	<i>Recommendations</i>
Pneumatic control system is leaky, antiquated, and un-reliable.	Upgrade all pneumatic control components to be tied into the existing DDC system.
Densely occupied spaces did not appear to include a means for demand control ventilation.	Add CO2 sensors and programming to the Gym, Cafeteria, Media Center, and classrooms to minimize
Abandoned pneumatic controls appeared to be present in some spaces.	Upgrade all pneumatic control components to be tied into the existing DDC system.

Image 20: Air compressor system

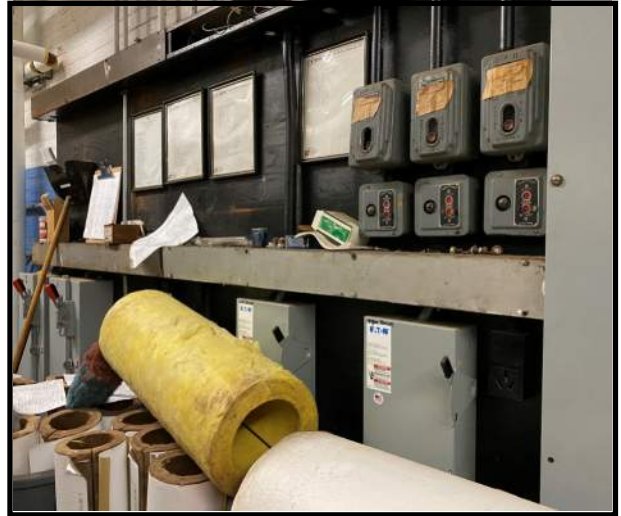
<i>Specific Issues</i>	<i>Recommendations</i>
Panelboards in many locations do not have code required working clearance. (Image 1) (Image 2) (Image 3) (Image 4) (Image 5)	Provide code required working clearance in front of all panelboards and electrical equipment.
Distribution panel, panelboards, and some disconnects, while in fair condition, are from a discontinued manufacturers and may have difficulties finding replacement parts. (Image 6) (Image 7) (Image 8) (Image 9)	Replace existing panels and breakers.
Shelving is obstructing working clearance for unit heat disconnect and wire trough. (Image 10) (Image 11)	Remove shelving to provide proper clearance.
Insufficient quantity of receptacles throughout the existing building resulting in the use of extension cords, plug strips. (Image 12) (Image 13) (Image 14) (Image 15) (Image 16) (Image 17)	Provide more receptacles in both classrooms and offices.

Image 2: Panel boards with storage in front

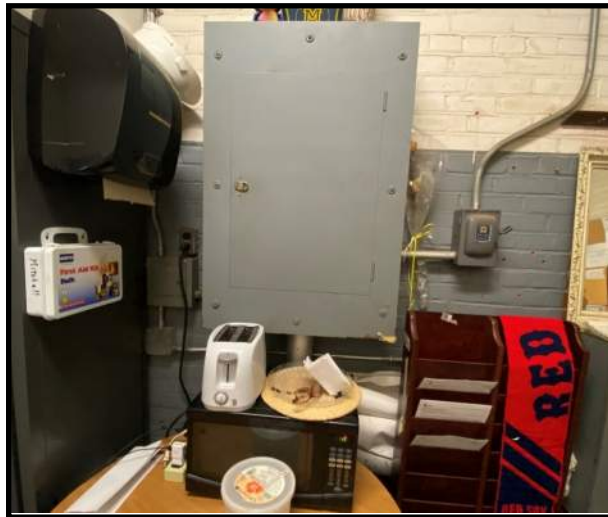
Image 3: Panel board with furniture in front

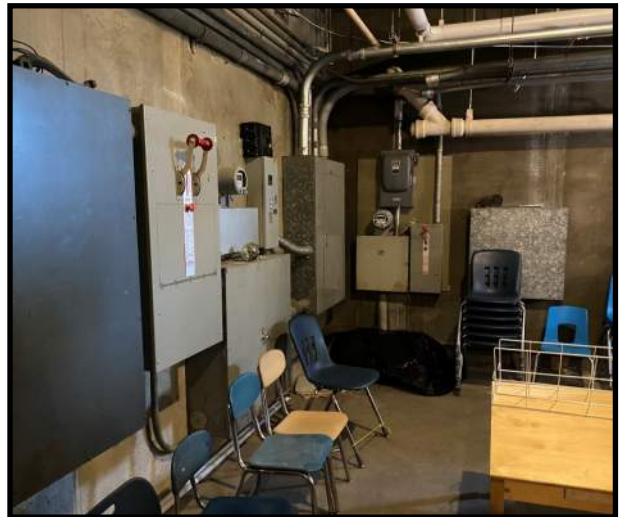
Image 4: Panel boards with storage in front

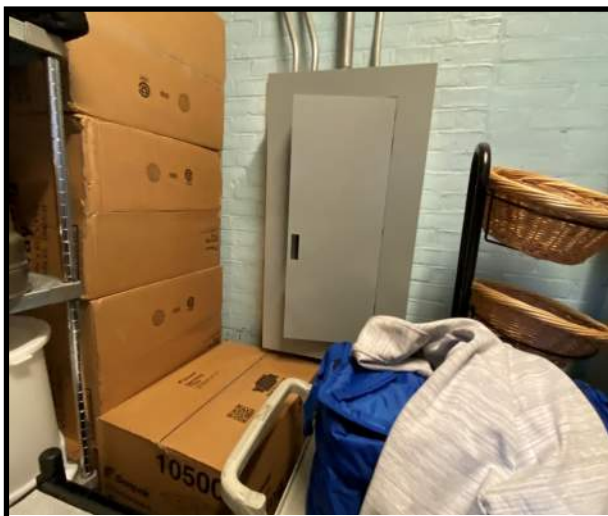
Image 5: Panel board with storage in front

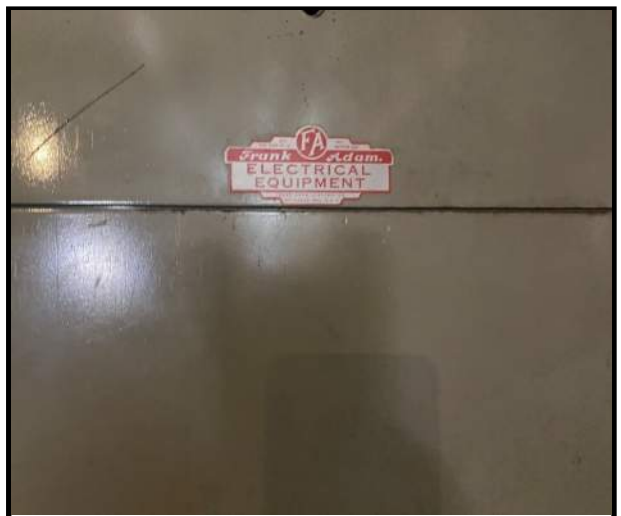
The Mitchell School currently has 3 electrical services, all 208Y/120V, 3-phase, 4-wire. Service 1 runs underground and serves the main building, which is split into a metered 600 Amp section and a metered 200 Amp and 100 Amp sections. Equipment for this service appears to be original to the building, and manufactured by Frank Adams, which no longer exists, making replacement parts difficult to acquire.

Image 6: Mfg Tag on equipment
