## EXISTING CONDITIONS ASSESSMENT

## EXISTING SITE & BUILDING DATA

Nitsch Engineering has performed research of the existing site conditions for the Mitchell School at 187 Brookline Street in Needham, Massachusetts. Nitsch Engineering also conducted a site visit on December 13, 2019 to observe the overall site, take pictures and provide a preliminary outline of short and long term needs for the school. Nitsch Engineering included anticipated site permitting requirements for the Mitchell School for any proposed site work.

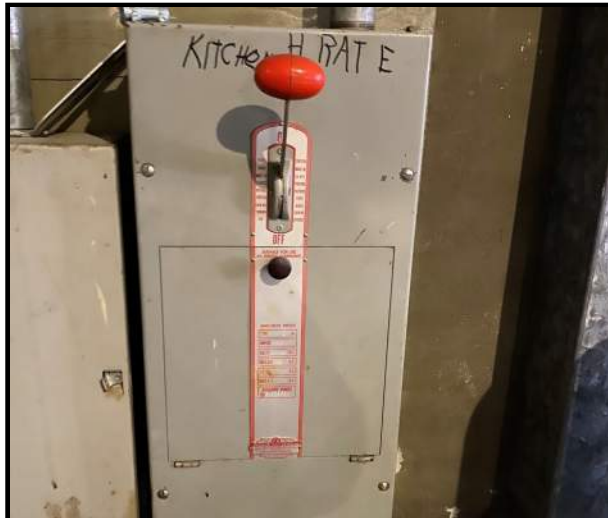
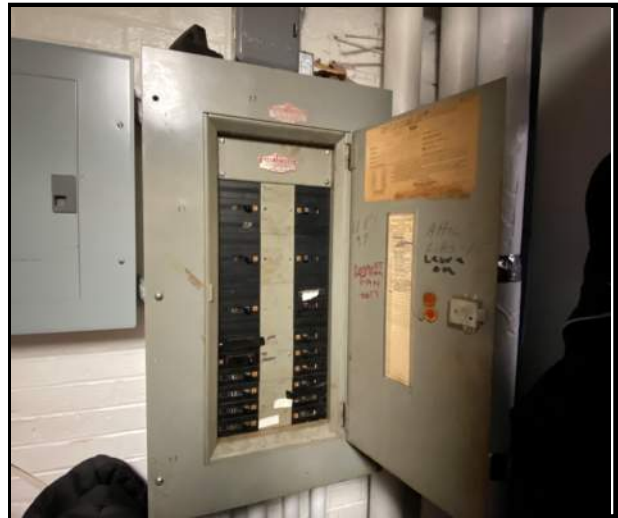
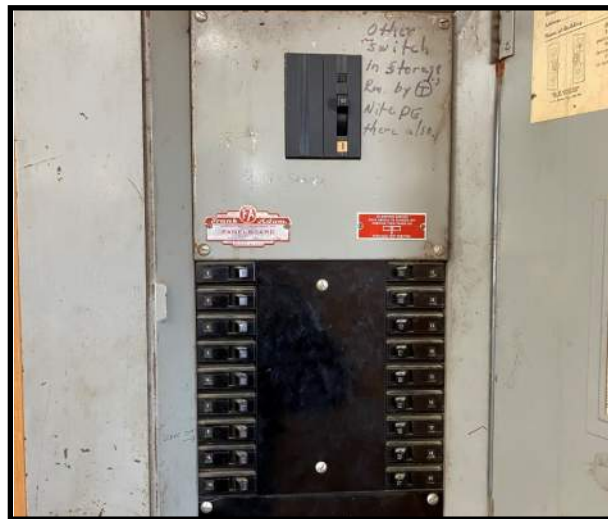
The Mitchell School currently has 3 electrical services, all 208Y/120V, 3-phase, 4-wire. Service 1 runs underground and serves the main building, which is split into a metered 600 Amp section and a metered 200 Amp and 100 Amp sections. Equipment for this service appears to be original to the building, and manufactured by Frank Adams, which no longer exists, making replacement parts difficult to acquire.

Image 7: Antiquated equipment mfg

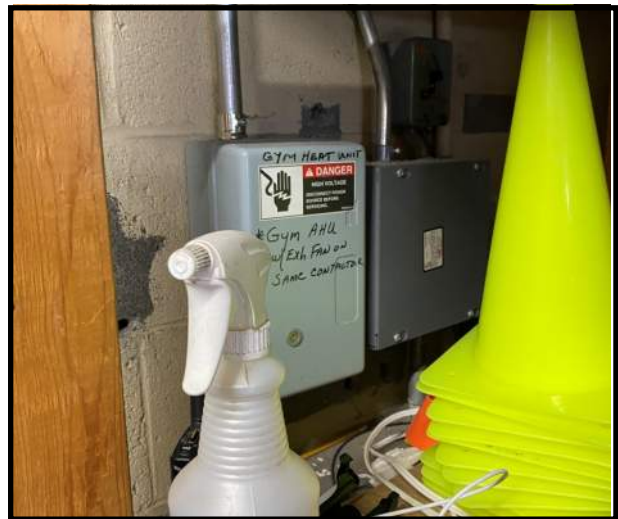
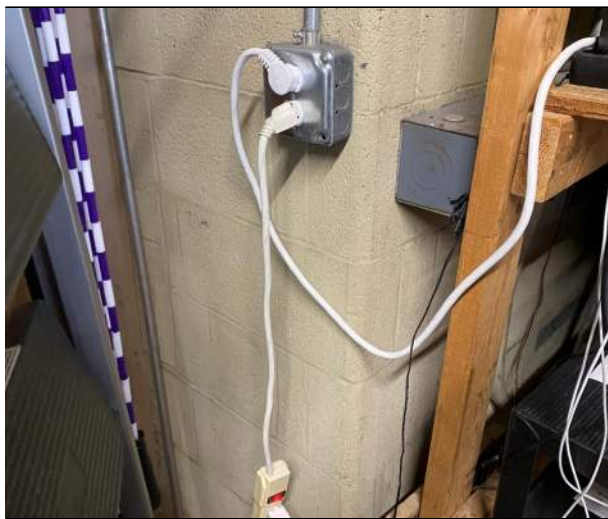
<i>Specific Issues</i>	<i>Recommendations</i>
Panelboards in many locations do not have code required working clearance. (Image 1) (Image 2) (Image 3) (Image 4) (Image 5)	Provide code required working clearance in front of all panelboards and electrical equipment.
Distribution panel, panelboards, and some disconnects, while in fair condition, are from a discontinued manufacturers and may have difficulties finding replacement parts. (Image 6) (Image 7) (Image 8) (Image 9)	Replace existing panels and breakers.
Shelving is obstructing working clearance for unit heat disconnect and wire trough. (Image 10) (Image 11)	Remove shelving to provide proper clearance.
Insufficient quantity of receptacles throughout the existing building resulting in the use of extension cords, plug strips. (Image 12) (Image 13) (Image 14) (Image 15) (Image 16) (Image 17)	Provide more receptacles in both classrooms and offices.

Image 10: Shelving blocks access to equipment

Image 11: Shelving unit blocks access to equipment

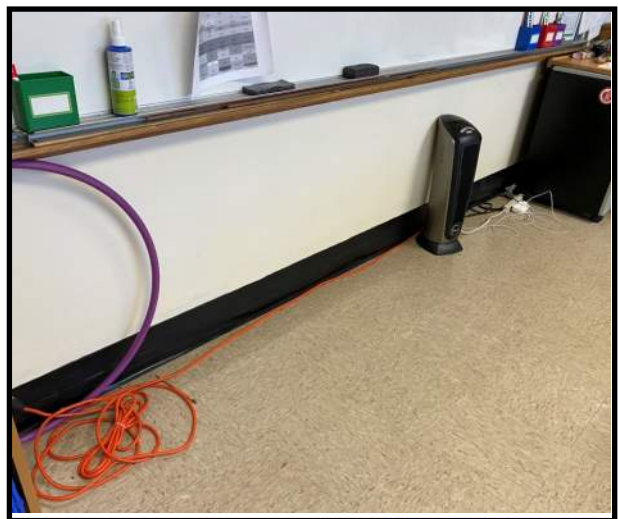
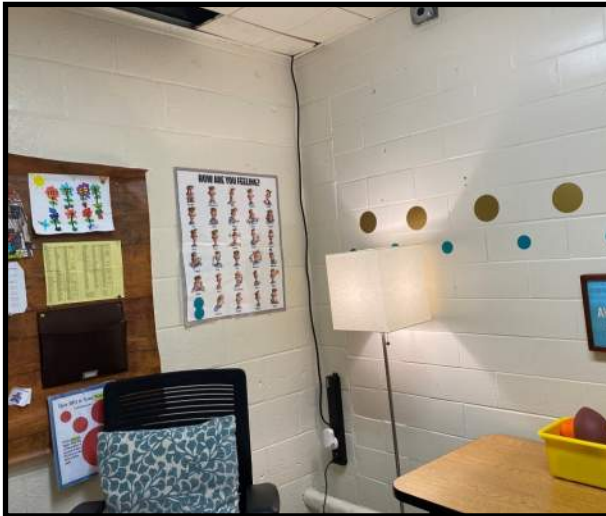
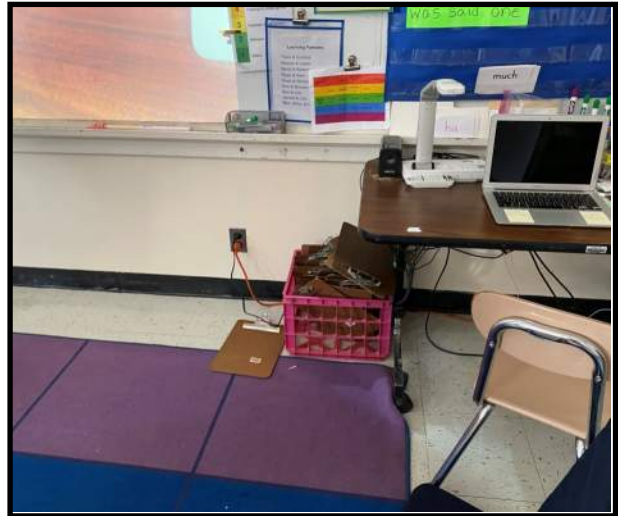
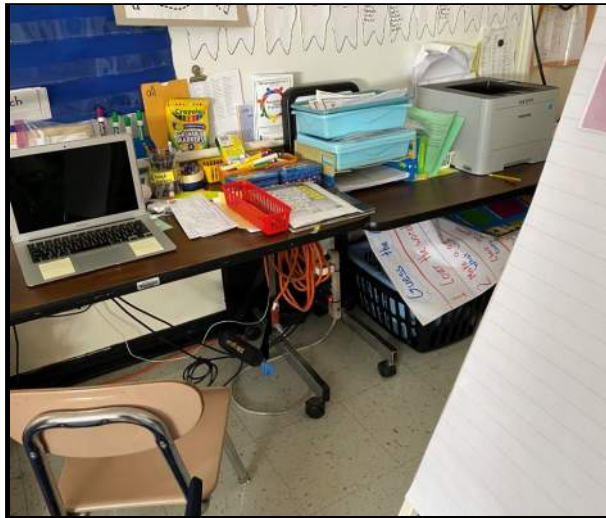
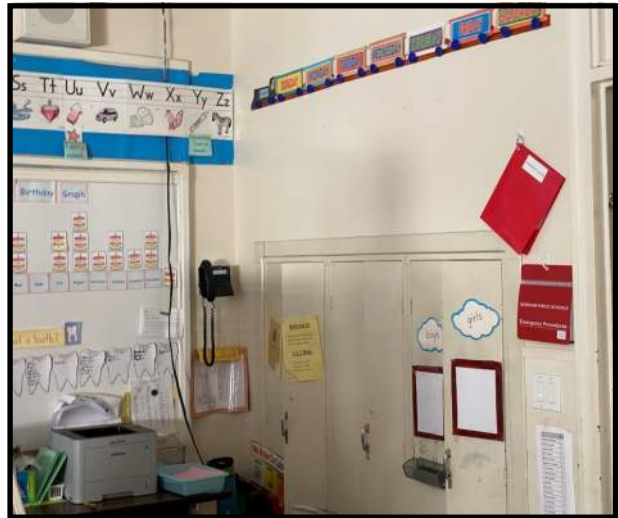
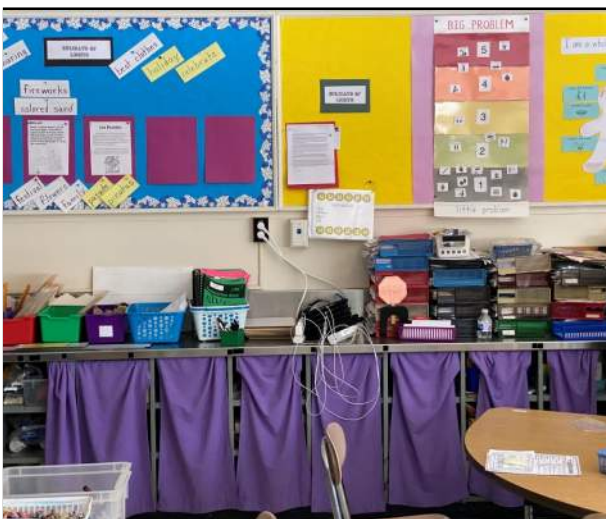
Image 12: Use of extension cords

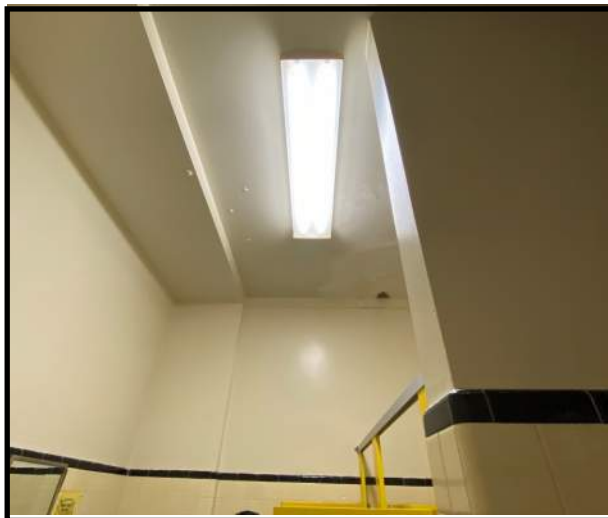
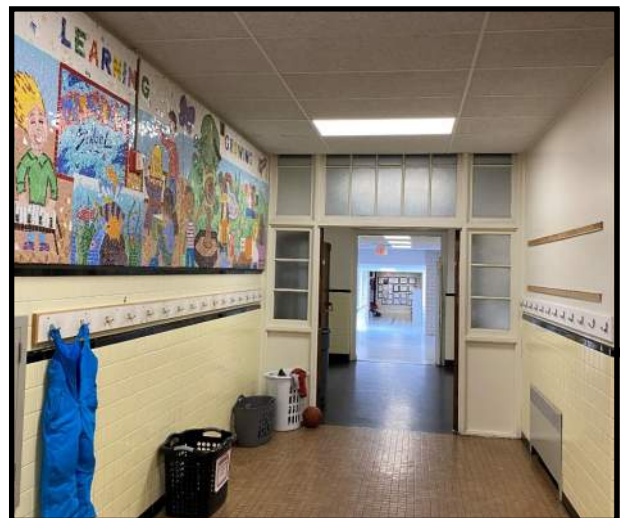
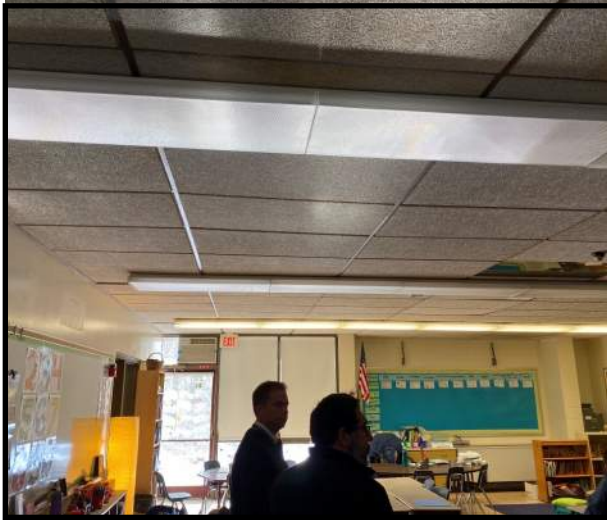
<i>Specific Issues</i>	<i>Recommendations</i>
Lighting levels appear adequate for classrooms and offices. Fixtures look to be in good condition but the majority of fixtures are inefficient fluorescent lamps. (Image 18) (Image 19) (Image 20)	Lighting throughout the building should be upgraded to energy efficient LED lighting.
Some fixtures had missing lamps. (Image 21)	Provide new fluorescent lamps or provide new LED fixtures.
Combination occupancy/photo sensors are not adequately spaced. There is no occupancy sensors in corridors. There is no dimming provided or centralized management of lighting controls. (Image 21) (Image 25)	Provide a new automatic lighting system to meet code.

Image 18: Lighting restroom

Image 19: Lighting in corridor

Image 20: Classroom lighting

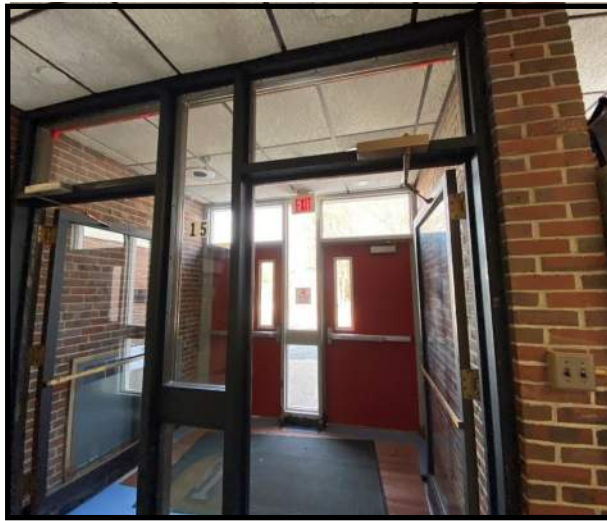
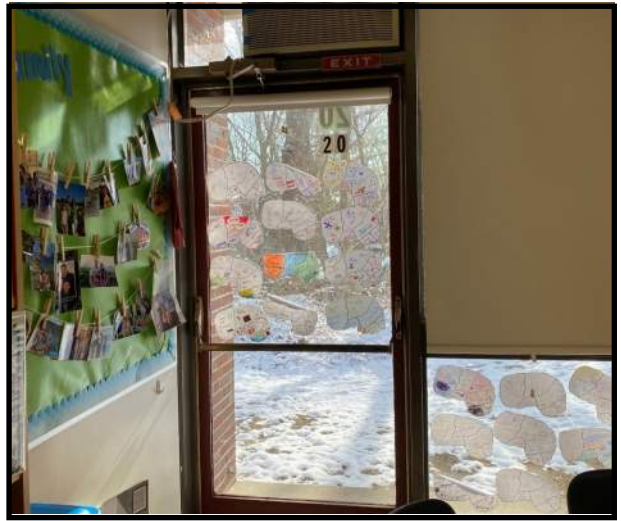
Image 22: Third condensate receiver

Image 23: Vestibule

<i>Specific Issues</i>	<i>Recommendations</i>
Several egress doors exiting to grade do not have EBU's. (Image 22) (Image 23)	Provide new LED type EBU's or fixtures with an emergency driver for emergency egress lighting.
No exterior emergency egress lighting at some doors on original building. It was reported at time of visit that most exterior lighting does not work. (Image 26) (Image 27)	Provide new weatherproof LED egress lighting with remote emergency battery.
No exterior emergency egress lighting in the courtyard or exit signage. (Image 28)	Provide new weatherproof LED egress lighting with remote emergency battery and weatherproof exit signs.

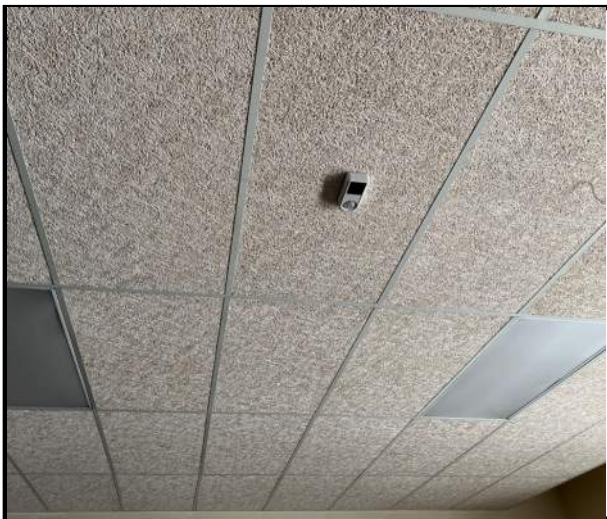
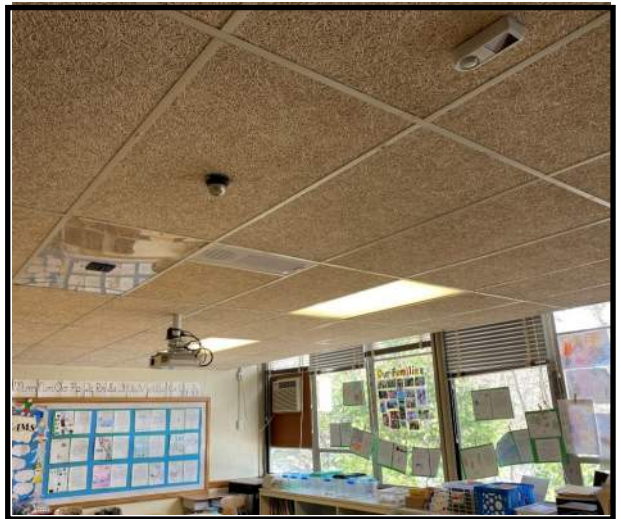
Image 24: Occupancy Control

Image 25: Occupancy Control

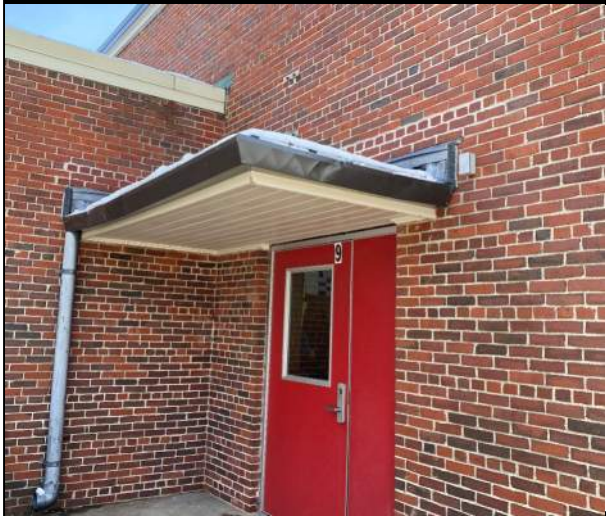
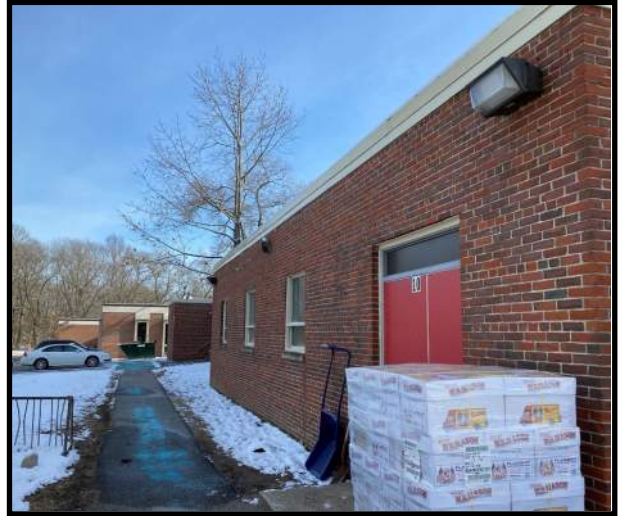
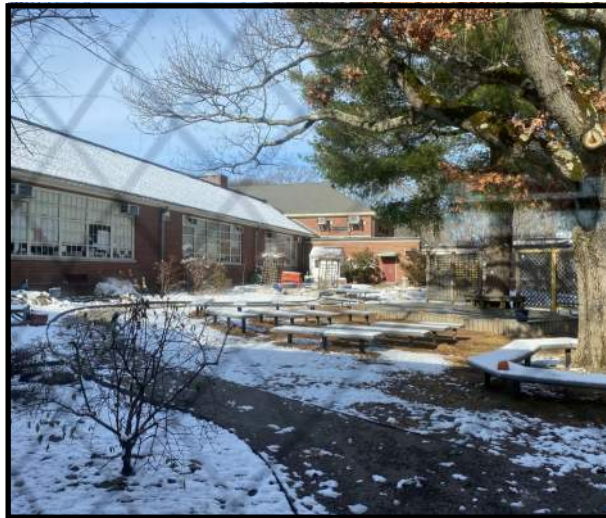
Image 26: Exterior door

Image 27: Exterior door and lighting

Image 28: Courtyard with no exterior lighting

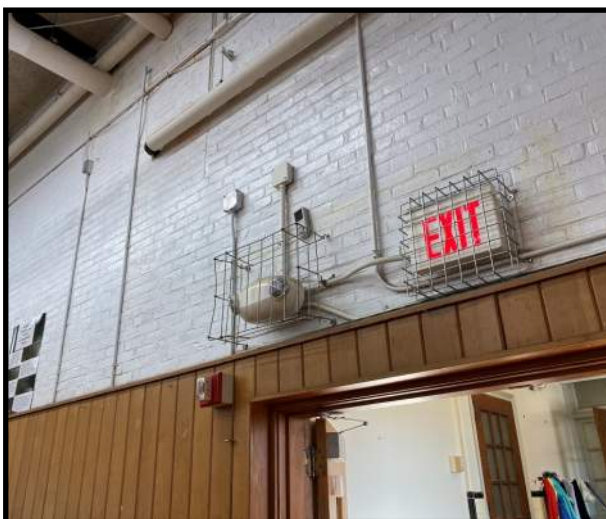
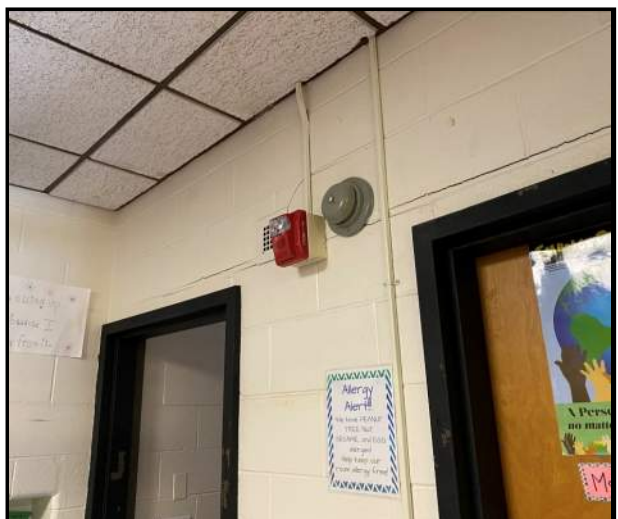
<i>Specific Issues</i>	<i>Recommendations</i>
System uses horn/strobes for notification which is not code compliant for an educational use building. (Image 29) (Image 30) (Image 31)	Provide a code compliant speaker/strobe system.
Older heat detectors are used throughout in lieu of smoke detectors. While this layout for early detection was allowed at one point, it does not meet current code. (Image 32) (Image 33)	Provide smoke detectors throughout.
Fire Alarm pull stations are missing from some egress doors that lead outside. (Image 34) (Image 35) (Image 36)	Provide manual pull stations per code.
No notification devices in classrooms or bathrooms.	Provide code-compliant notification devices throughout.

Image 29: Emergency lighting

Image 30: Horns and strobe

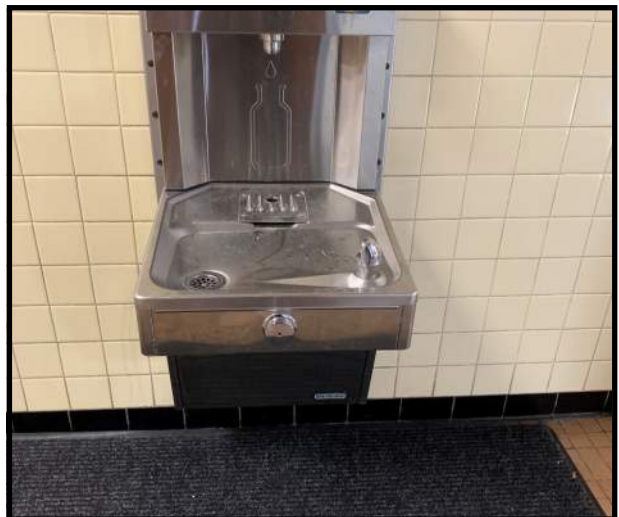
Electric water coolers are surface mounted, wall hung, non-accessible units with bottle filler (Image 6).

Image 6: Drinking fountain with bottle filler (corridor)

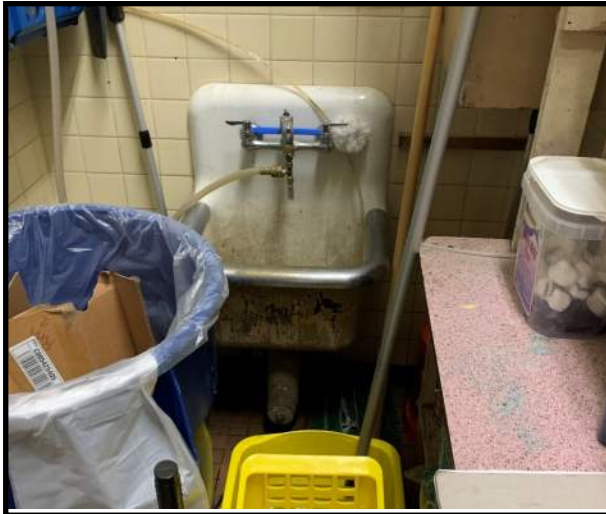
Image 7: Janitor sink

Janitor's sinks are generally trap standard mounted, enameled cast iron sinks (Image 7). There are also mop receptors in the building (Image 8). Faucets are equipped with vacuum breakers.

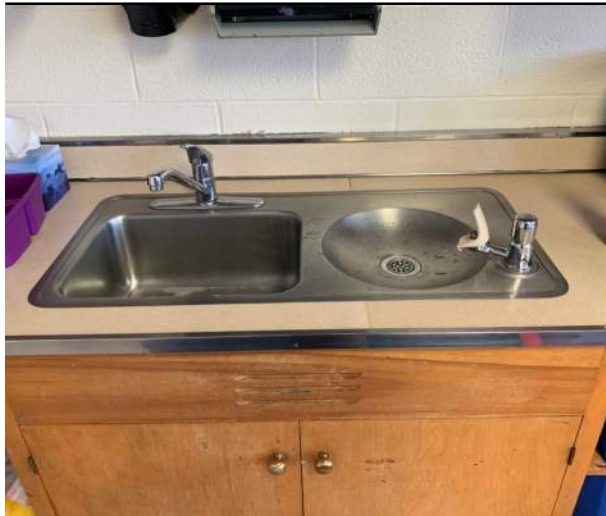
Image 9: Classroom sink

Classroom sinks are stainless steel with hot and cold water faucets and include a bubbler (Image 9).

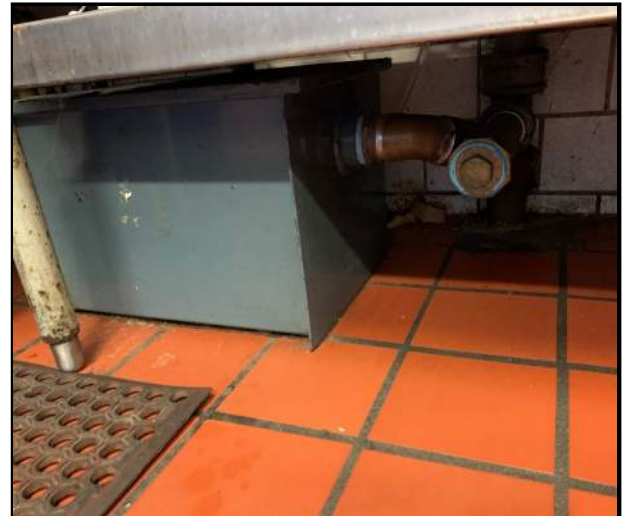
Image 10: Greece trap in kitchen

The pot washing sink is fitted with a grease interceptor in the floor (Image 10).

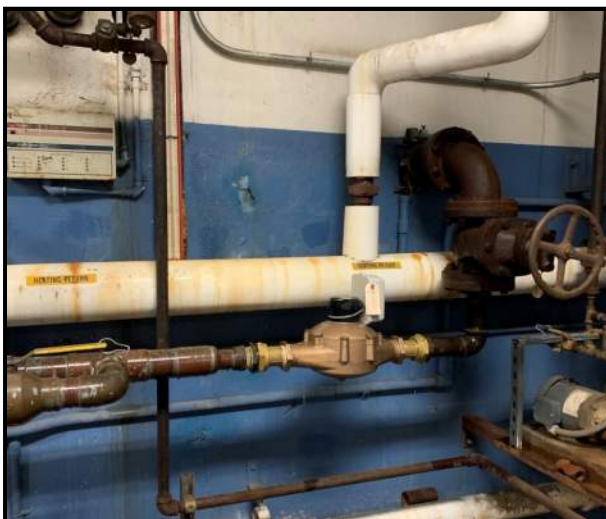
Image 11: Main domestic water

The main domestic water service is located in the Basement Mechanical Room. The service is 4" in size and includes a 2" meter (Image 11). The main domestic cold-water distribution is 2" in size. The majority of the domestic distribution piping is located in the ceiling of the crawl spaces throughout the facility.

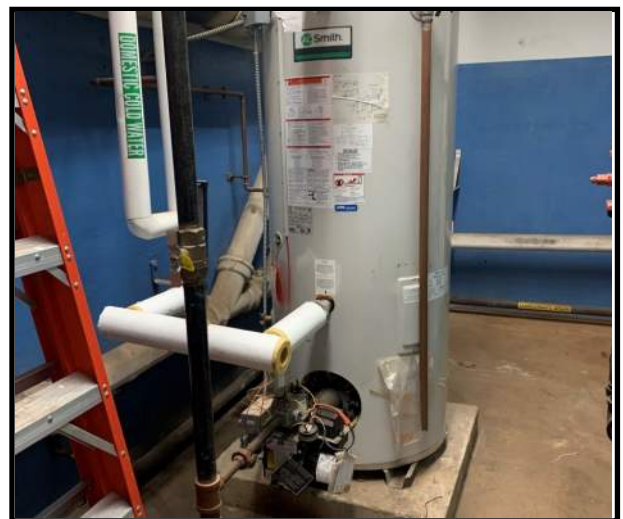
Image 12: Water heater

Domestic hot water in the building is generated through a gas-fired storage type water heater (Image 12). The hot water systems are recirculated (Image 13). There are no thermostatic mixing valves on

the systems to prevent scalding. The water heater has a natural gas input of 370,000 BTUH and 80 gallon storage capacity. Water heater is relatively new and in good condition.

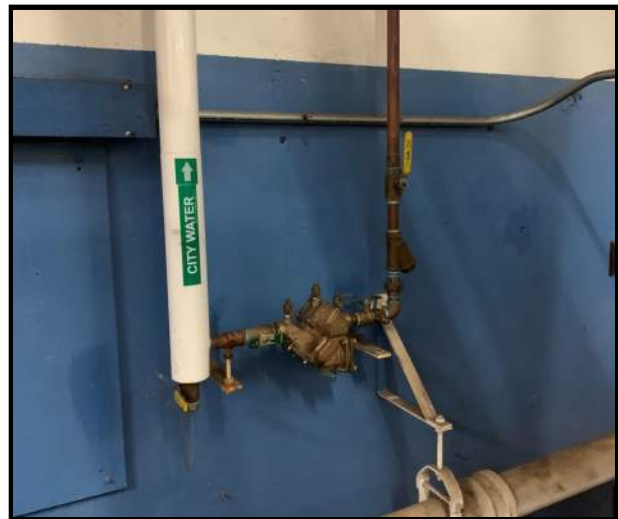
Image 14: Backflow preventor

A cold water make-up line for boilers includes a reduced pressure backflow preventer (Image 14).

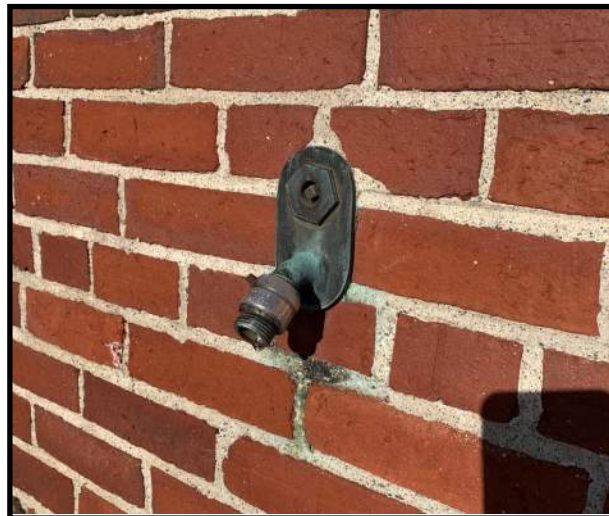
Image 15: Wall hydrant

Wall hydrants with vacuum breakers are provided around the building's perimeter (Image 15).

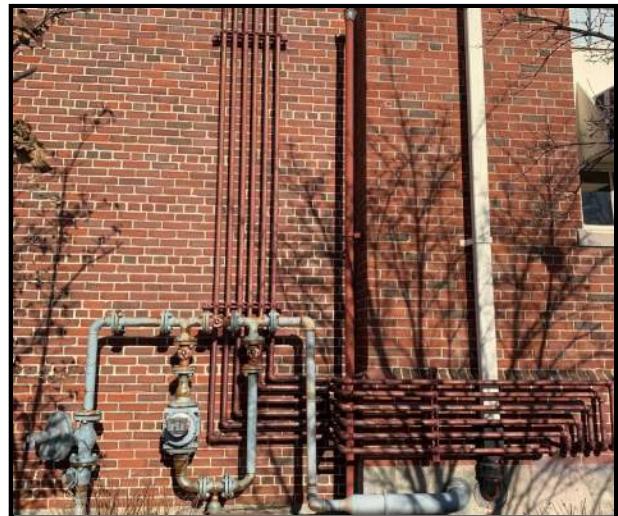
Image 16: Gas meter

An elevated pressure natural gas service is supplied to the building. The exterior gas service includes a pressure regulator and gas meter at exterior wall (Image 16). Natural gas is distributed throughout the building from this location to the boilers (Image 17), domestic water heater and kitchen equipment.

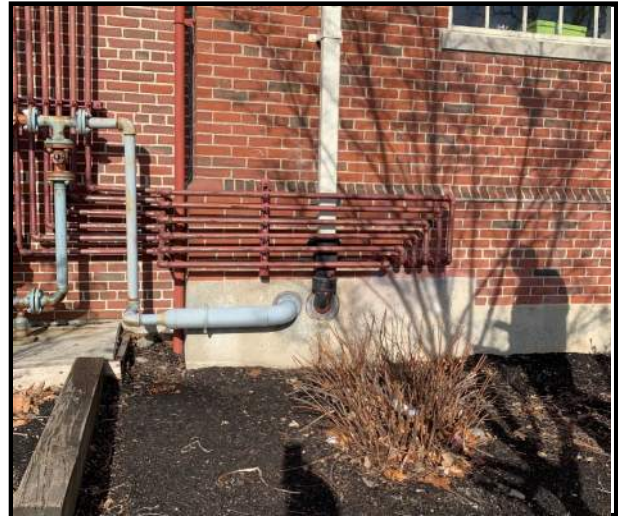
Image 18: Gas piping

Gas piping is black steel with a combination of screwed and welded joints and fittings depending on the size of the pipe. Gas piping, including gas regulator vents on the roof or exterior is painted to prevent rust from forming (Image 18). Kitchen supply is equipped with an automatic shutoff valve.

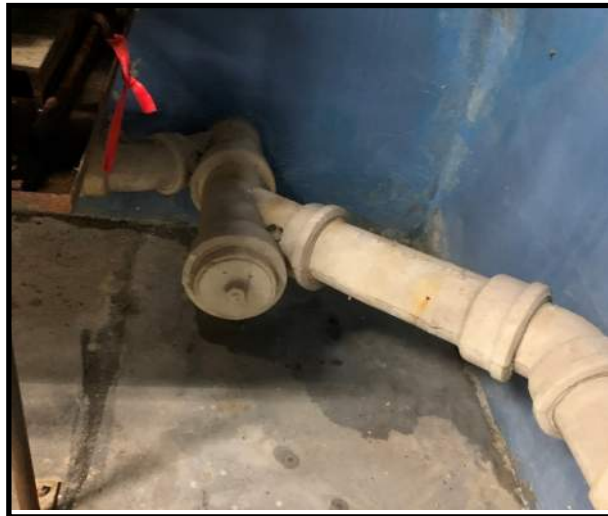
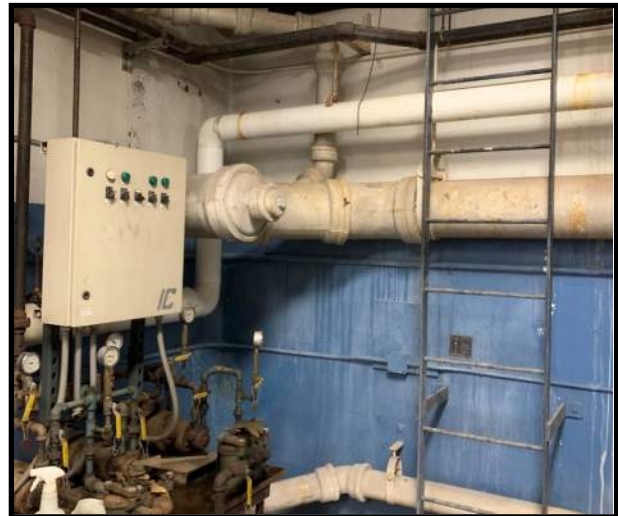
Cast iron is used for sanitary and storm drainage. Where visible, the cast iron pipe appears to have exceeded its life expectancy (Image 19) (Image 20). Smaller pipe sizes appear to be copper.

<i>Specific Issues</i>	<i>Recommendations</i>
Cast iron sanitary, waste, vent and storm piping has exceeded its life expectancy.	Due to its age, a complete new drainage piping is recommended as it has served its useful life.

Image 19: Cast iron piping

Image 20: Cast iron piping

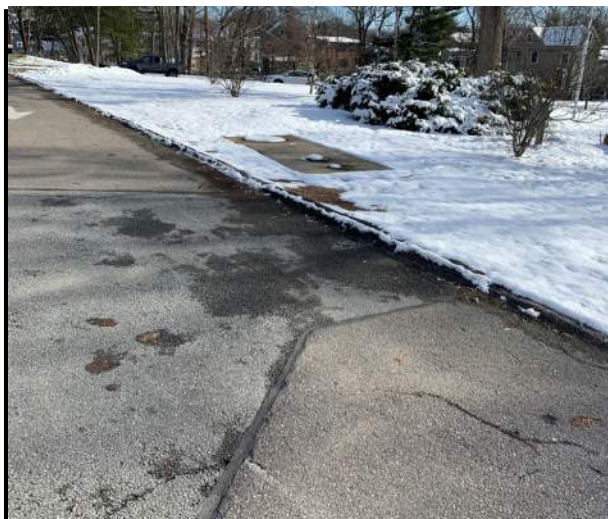
Image 21: Exterior grease trap

The Kitchen waste is directed to an exterior grease trap (Image 21).

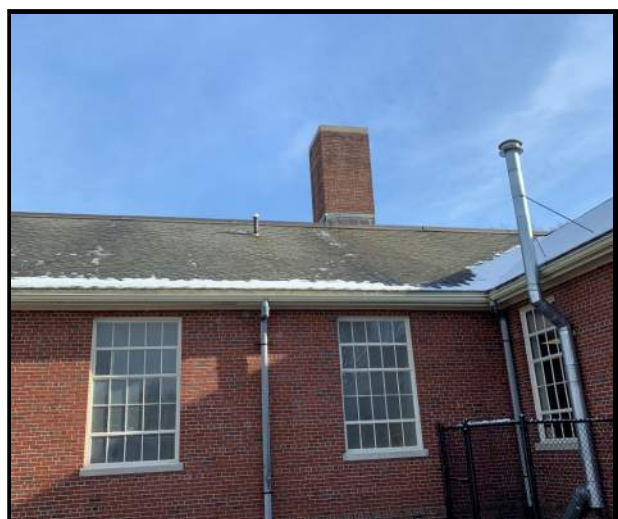
Image 22: Downspouts

Roof drains are located throughout flat roof areas. The horizontal storm piping which is collecting rain-water from roof drains is insulated. In addition to an interior roof drainage system, some roof drainage is being directed by gutters and downspouts to the site storm system by downspout boots (Image 22).
